**Minimum Material Condition (MMC)**  
**2014-18 GMC SIERRA RH UPR INBOARD HEADLIGHT TAB KIT ALL**  
**P/N 25-10001**

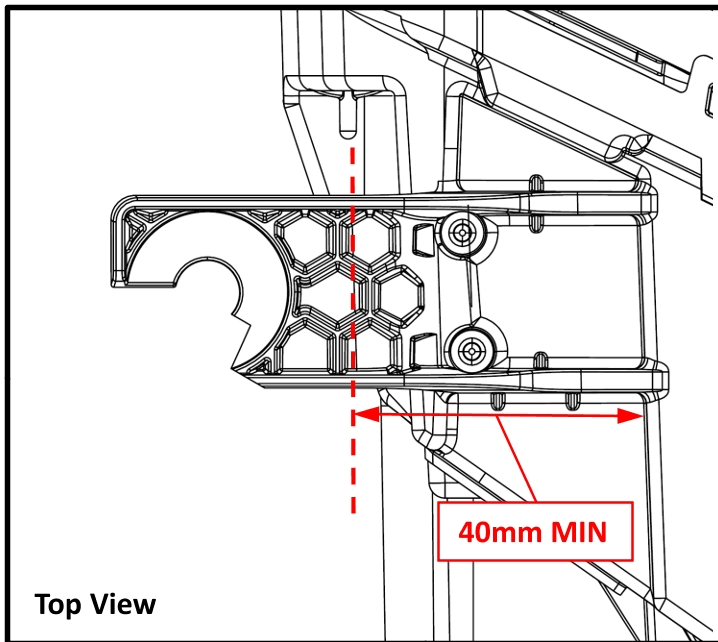
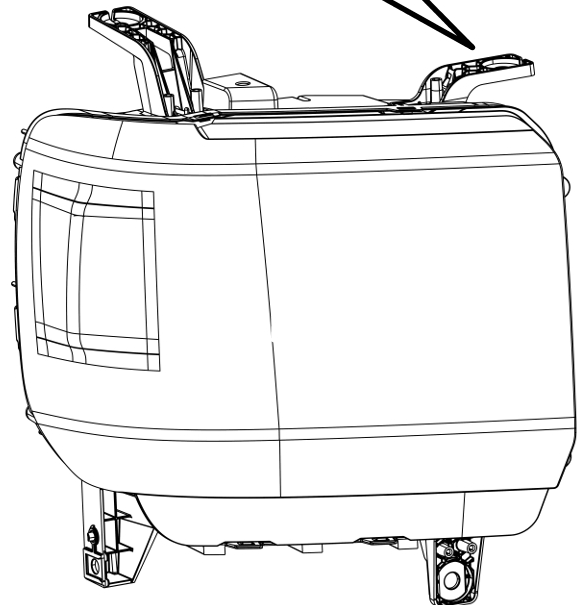
1. Using a metric scale or ruler, measure your lamp at the reference points given in the figure below.
2. If the broken mounting tab meets the Minimum Material Condition value(MIN), then your lamp can be repaired using this kit.
3. If the broken mounting tab does not meet the Minimum Material Condition value(MIN), then your lamp is not a candidate for this repair kit.
4. If your lamp's mounting tabs have been repaired previously by any method, then your lamp is not a candidate for this repair kit.
