Minimum Material Condition (MMC)
2016-18 CHEVY SILVERADO 1500 HID LED LH LWR INBOARD HEADLIGHT TAB KIT
P/N 25-10044

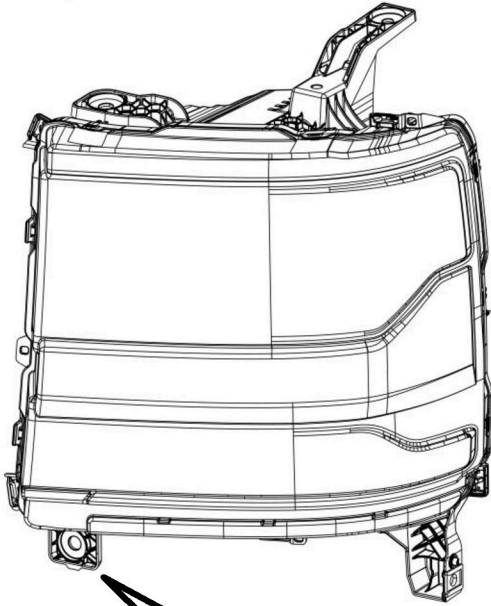
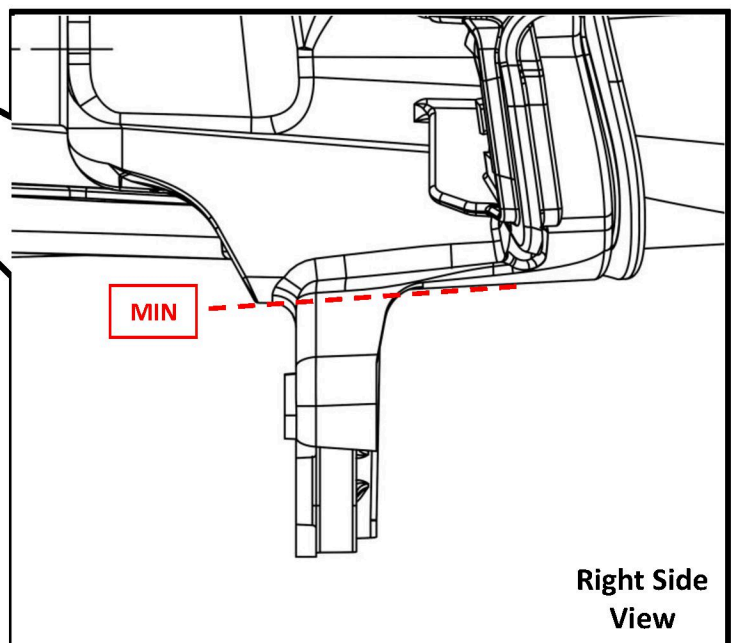
1. Using a metric scale or ruler, measure your lamp at the reference points given in the figure below.
2. If the broken mounting tab meets the Minimum Material Condition value(MIN), then your lamp can be repaired using this kit.
3. If the broken mounting tab does not meet the Minimum Material Condition value(MIN), then your lamp is not a candidate for this repair kit.
4. If your lamp's mounting tabs have been repaired previously by any method, then your lamp is not a candidate for this repair kit.
