Minimum Material Condition (MMC)
F150 LH LWR IB HEADLIGHT TAB LED
P/N 25-10123

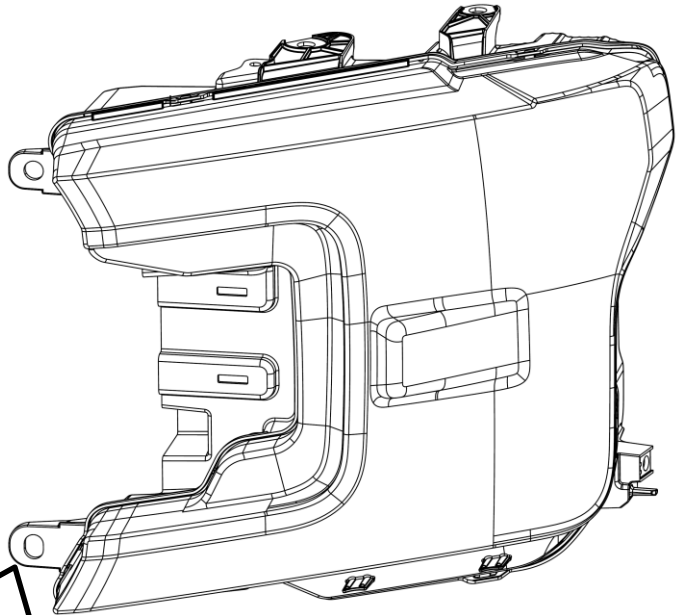
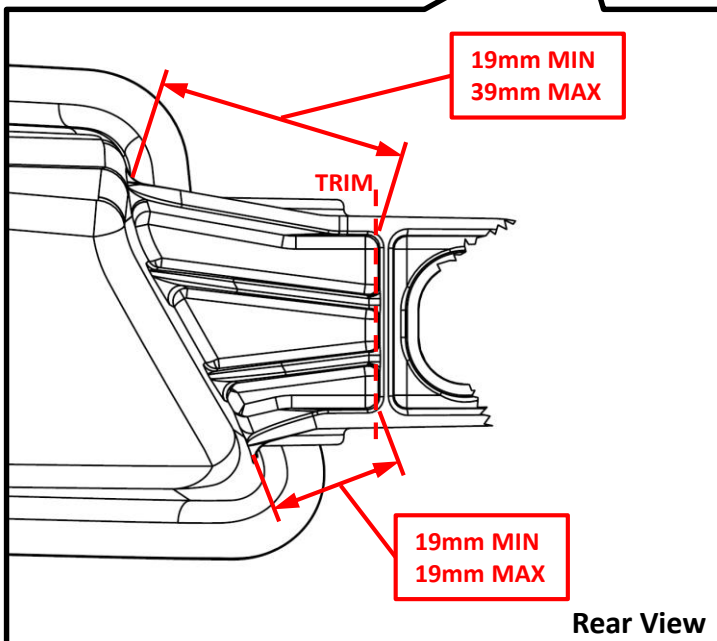
1. Using a metric scale or ruler, measure your lamp at the reference points given in the figure below.
2. If the broken mounting tab meets the Minimum Material Condition value(MIN), then your lamp can be repaired using this kit.
3. If the broken mounting tab does not meet the Minimum Material Condition value(MIN), then your lamp is not a candidate for this repair kit.
4. If your lamp's mounting tabs have been repaired previously by any method, then your lamp is not a candidate for this repair kit.
