**Minimum Material Condition (MMC)**  
**F150 LH UPR MID HEADLIGHT TAB HAL**  
**P/N 25-10131**

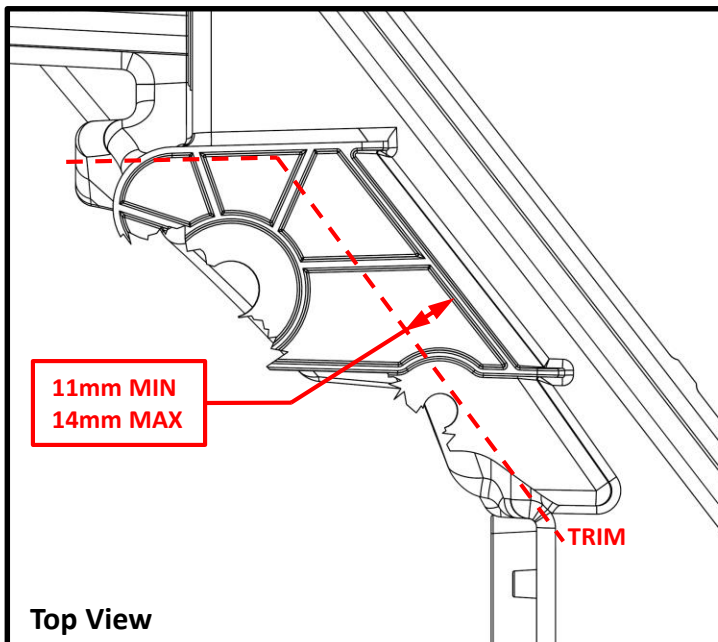
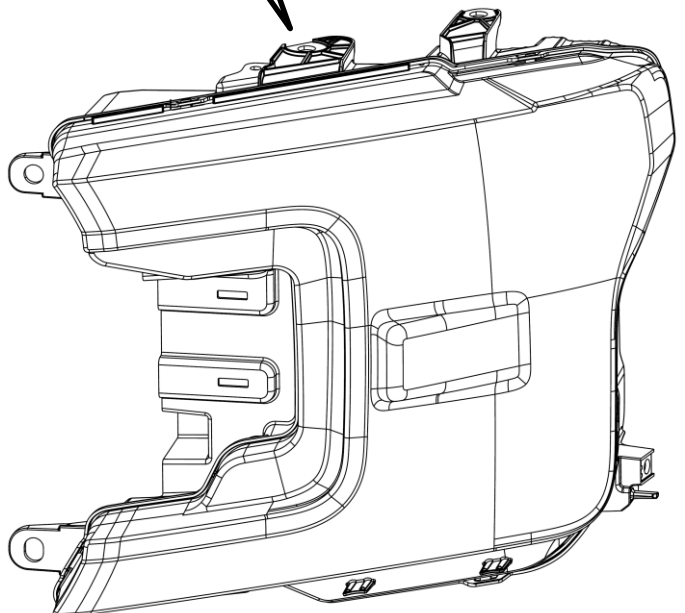
1. Using a metric scale or ruler, measure your lamp at the reference points given in the figure below.
2. If the broken mounting tab meets the Minimum Material Condition value(MIN), then your lamp can be repaired using this kit.
3. If the broken mounting tab does not meet the Minimum Material Condition value(MIN), then your lamp is not a candidate for this repair kit.
4. If your lamp's mounting tabs have been repaired previously by any method, then your lamp is not a candidate for this repair kit.
