2014-18 GMC SIERRA RH UPR OUTBOARD HEADLIGHT TAB KIT ALL P/N 25-10002

(Please visit CreativeRepairSolutions.com for detailed instruction videos.)

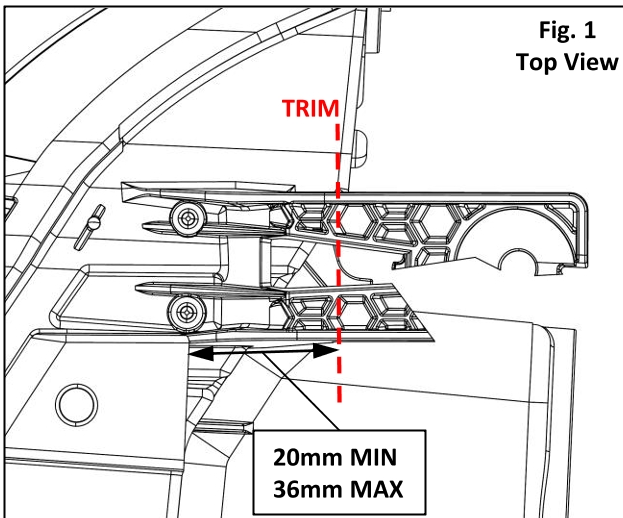
1. Trim: Using a cut-off wheel, trim the damaged tab to the **MAX** dimension whenever possible, **Fig. 1**. Make note of the trimming plane to which the **MAX** dimension refers, **Fig. 2**. The **MIN** indicates the least amount of material allowed for proper screw engagement. Next, Sand rough edges to remove excess material from trimming and to ensure a proper fit.

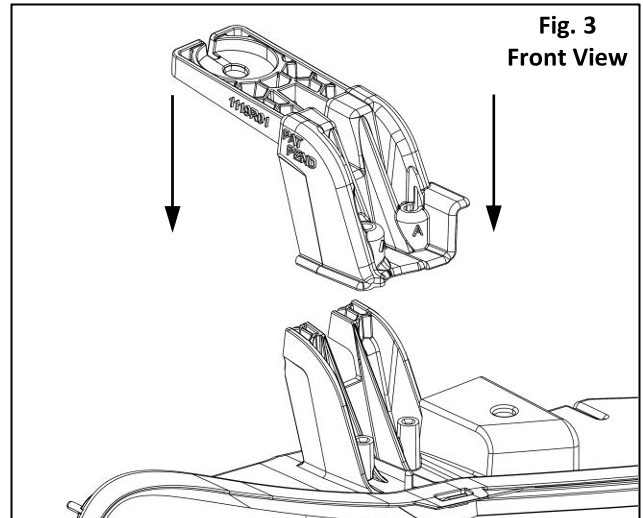
2. Dry-Fit: Dry-fit the repair tab(s) **Fig. 3**. If the tab fits without resistance and makes a flush fit to the housing, trimming is complete. If the tab resists installation re-trim the damaged tab, removing only small amounts of material. Repeat the Dry-Fit steps until the proper fit is achieved.

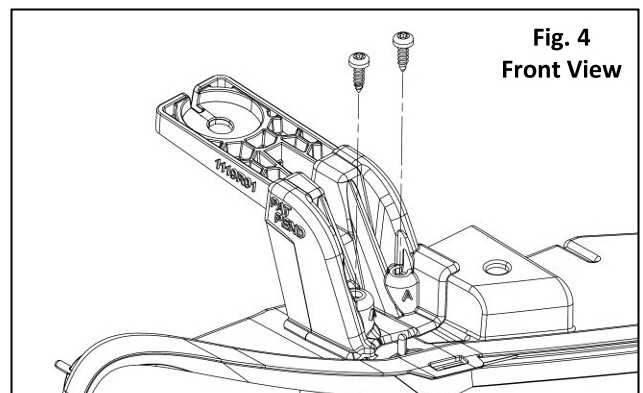
4. Install: Install the prepared tab(s) ensuring a flush fit to the housing **Fig. 4**. Next, drive the two 5/8" screws at the locations marked (A). Do not over-tighten the screws. Allow the glue to cure for approximately 30 minutes before installing the repaired headlight on the vehicle.

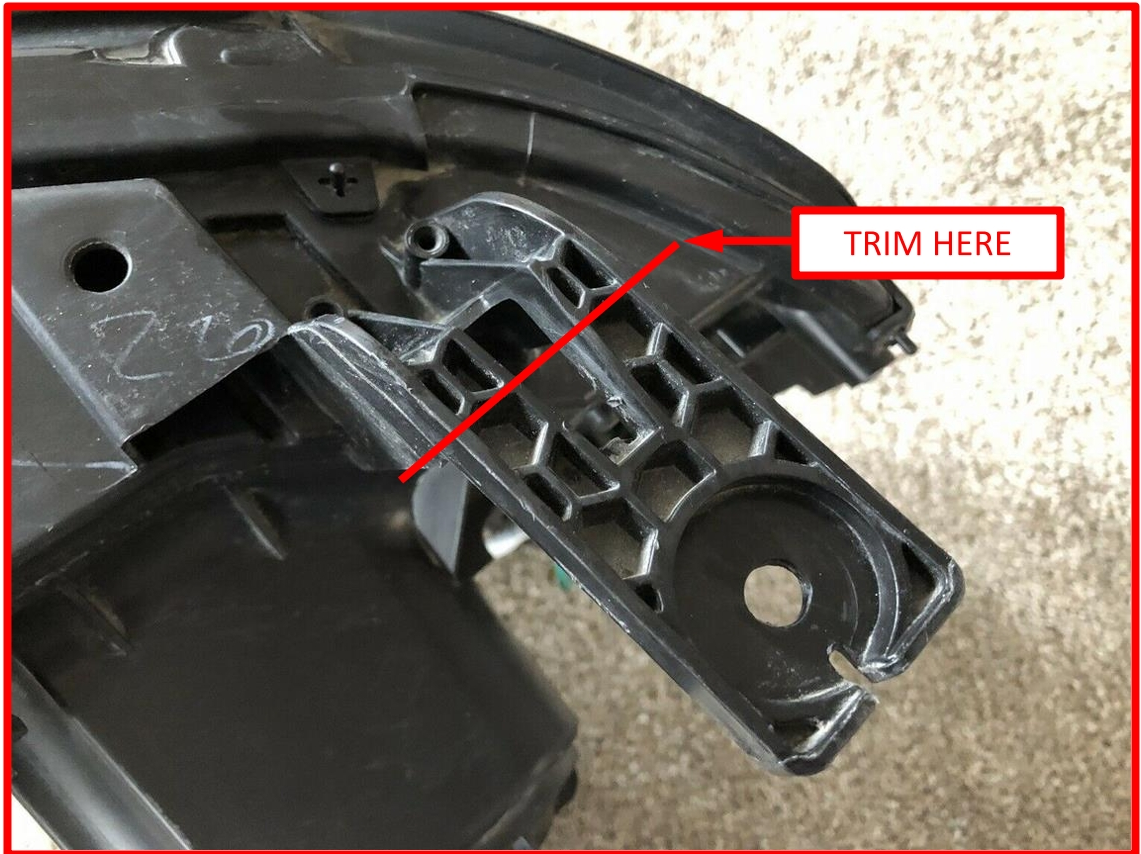
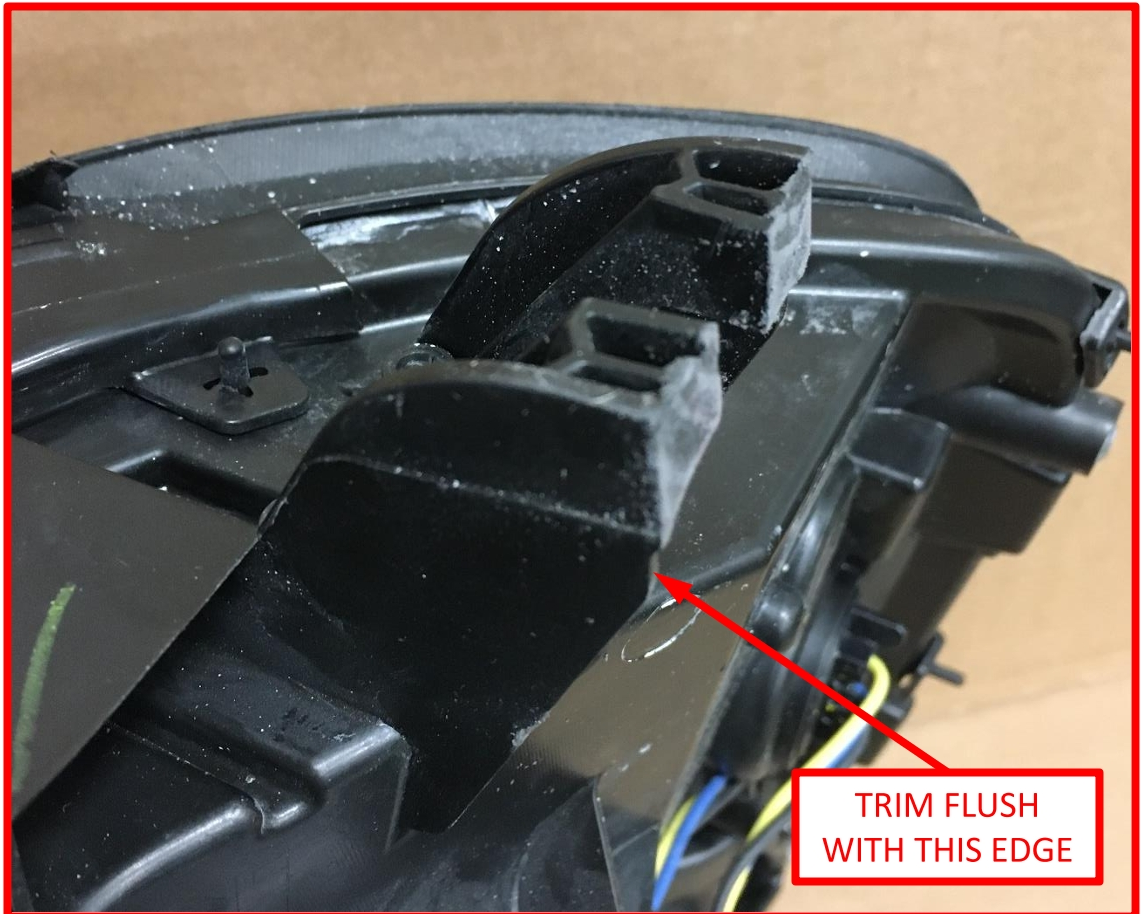
SEE REVERSE SIDE for views of properly trimmed headlamp tab.
