2014-18 GMC SIERRA LH UPR OUTBOARD HEADLIGHT TAB KIT ALL P/N 25-10006

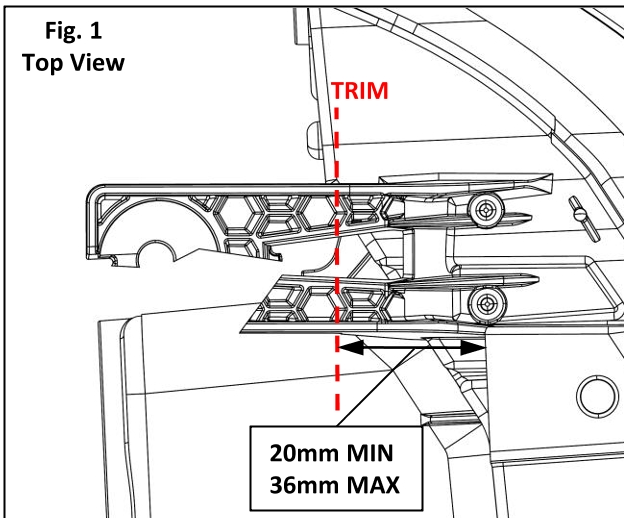
1. Trim: Using a cut-off wheel, trim the damaged tab to the **MAX** dimension whenever possible, **Fig. 1**. Make note of the trimming plane to which the **MAX** dimension refers, **Fig. 2**. The **MIN** indicates the least amount of material allowed for proper screw engagement. Next, Sand rough edges to remove excess material from trimming and to ensure a proper fit.

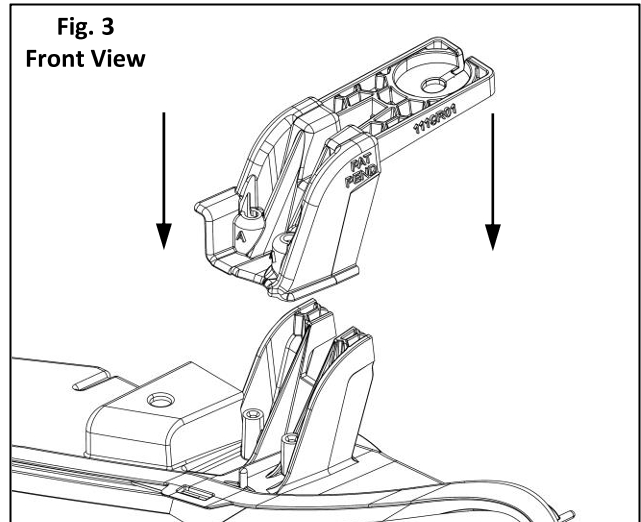
2. Dry-Fit: Dry-fit the repair tab(s) **Fig. 3**. If the tab fits without resistance and makes a flush fit to the housing, trimming is complete. If the tab resists installation re-trim the damaged tab, removing only small amounts of material. Repeat the Dry-Fit steps until the proper fit is achieved.

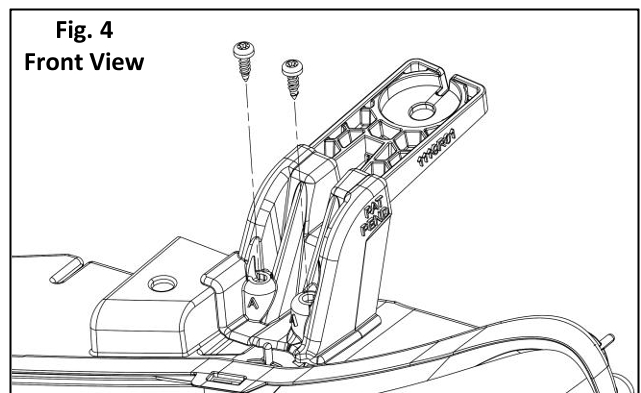
4. Install: Install the prepared tab(s) ensuring a flush fit to the housing **Fig. 4**. Next, drive the two 5/8" screws at the locations marked (A). Do not overtighten the screws. Allow the glue to cure for approximately 30 minutes before installing the repaired headlight on the vehicle.

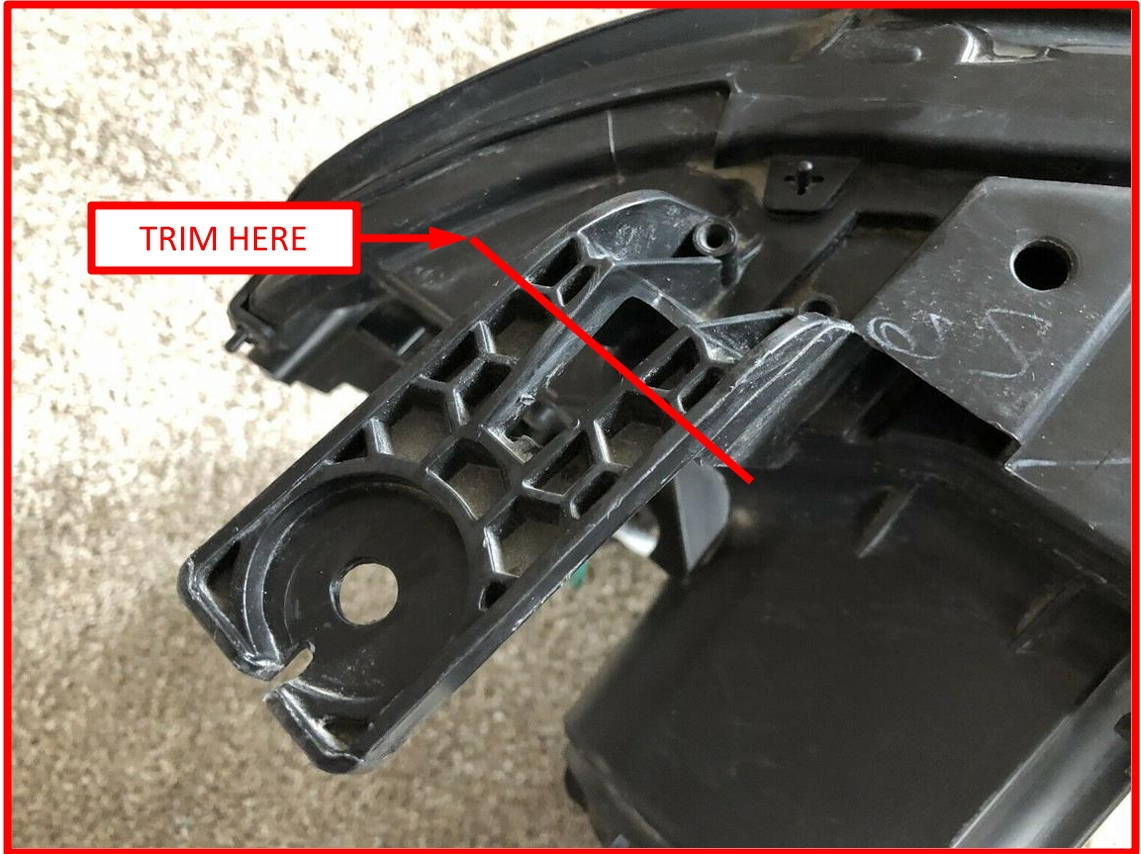
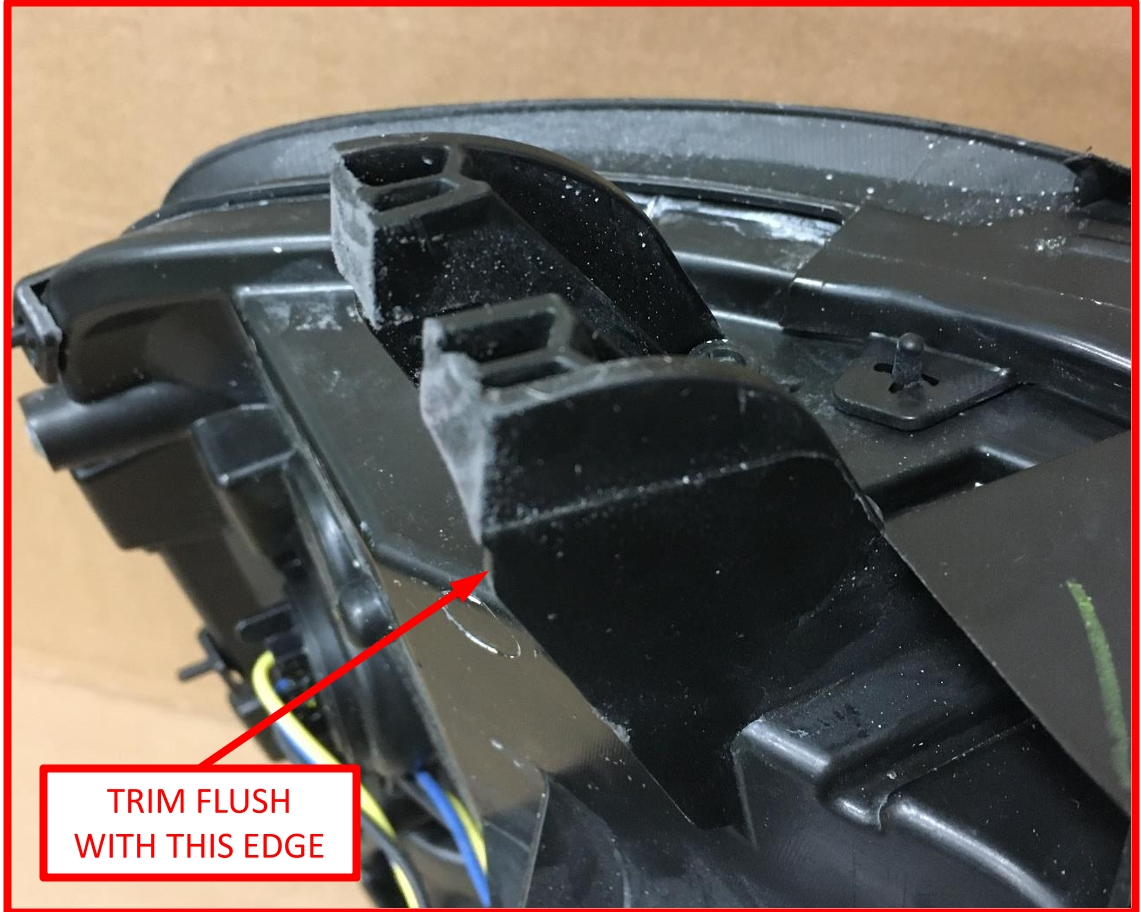
SEE REVERSE SIDE for views of properly trimmed headlamp tab.
