2014-18 GMC SIERRA LH LWR OUTBOARD HEADLIGHT TAB KIT ALL P/N 25-10007

(Please visit CreativeRepairSolutions.com for detailed instruction videos.)

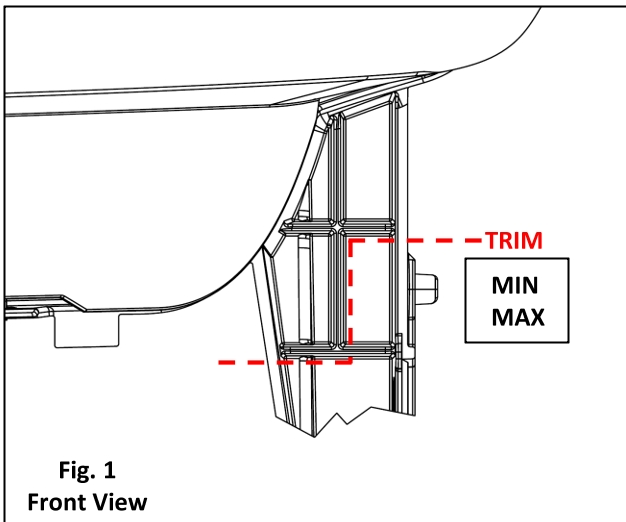
1. Trim: Using a cut-off wheel, trim the damaged tab to the **MAX** dimension whenever possible. Make note that in this case the trimming line is both the **MIN** and **MAX** dimension, **Fig. 1**. Trim flush to the ribs without removing them, **Fig. 2**. Next, Sand rough edges to remove excess material from trimming and to ensure a proper fit.

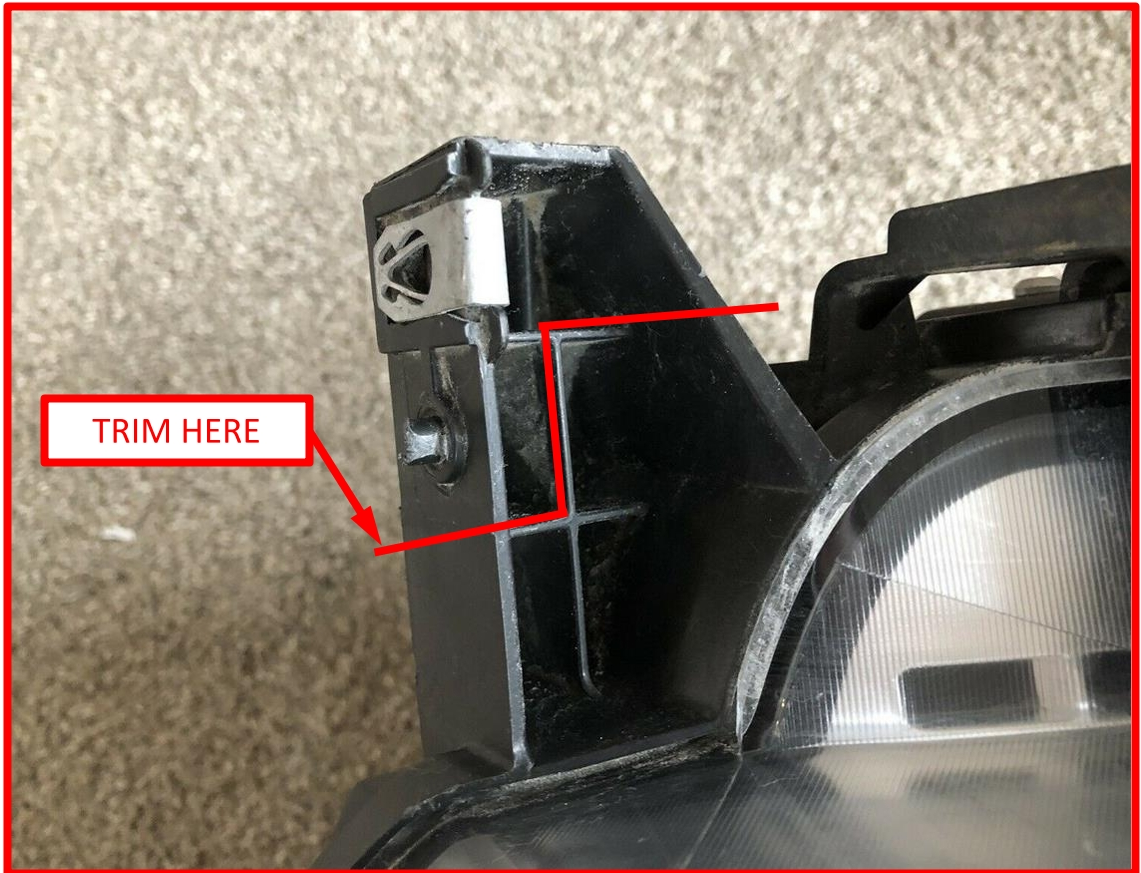
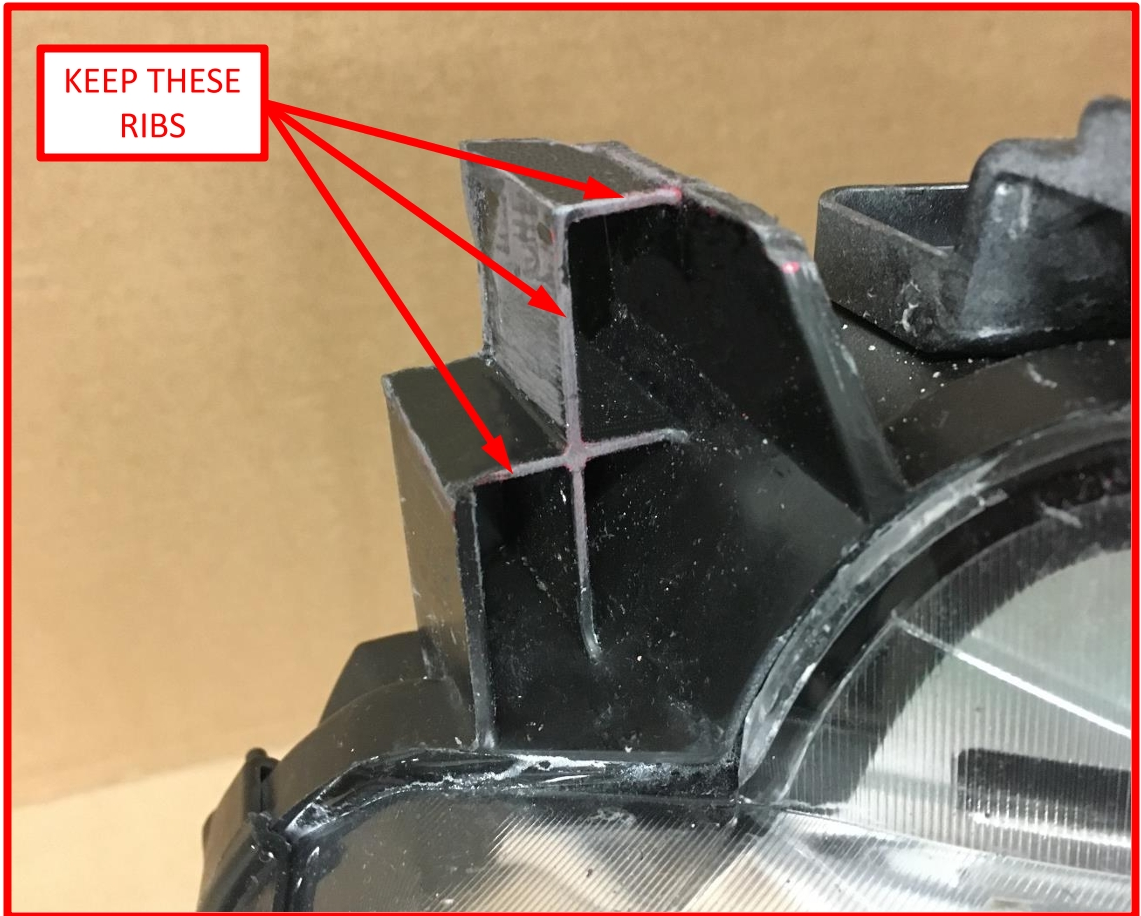
SEE REVERSE SIDE for views of properly trimmed headlamp tab.
