2016-18 CHEVY SILVERADO 1500 HID LED RH UPR OUTBOARD HEADLIGHT TAB KIT P/N 25-10038

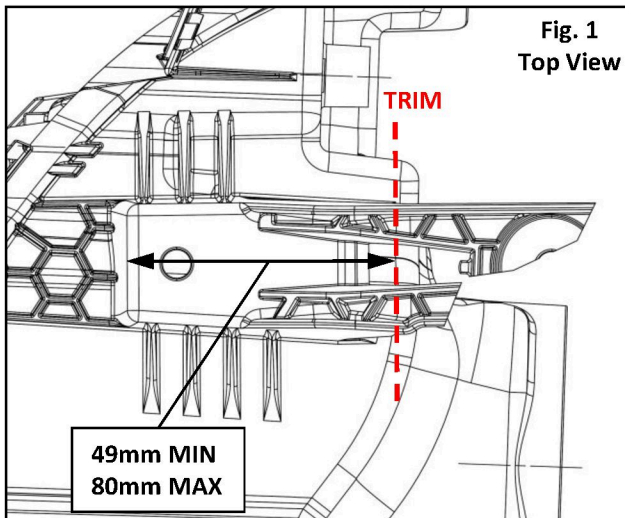
1. Trim: Using a cut-off wheel, trim the damaged tab to the **MAX** dimension whenever possible, **Fig. 1**. Make note of the trimming plane to which the **MAX** dimension refers, **Fig. 2**. The **MIN** indicates the least amount of material allowed for proper screw engagement. Next, Sand rough edges to remove excess material from trimming and to ensure a proper fit.

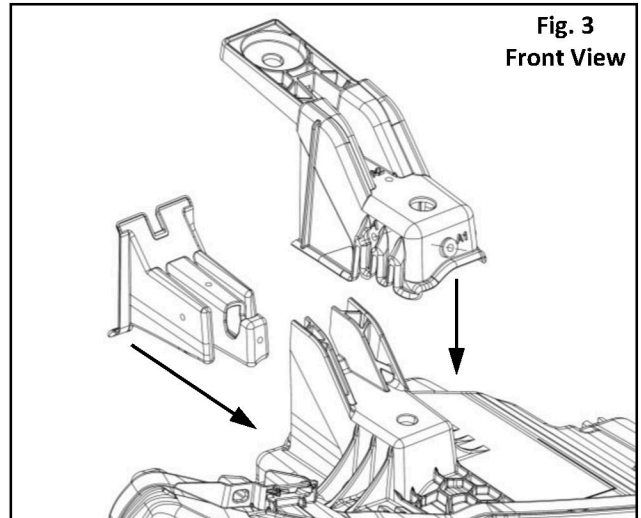
2. Dry-Fit: Dry-fit the repair tab(s) **Fig. 3**. If the tab fits without resistance and makes a flush fit to the housing, trimming is complete. If the tab resists installation re-trim the damaged tab, removing only small amounts of material. Repeat the Dry-Fit steps until the proper fit is achieved.

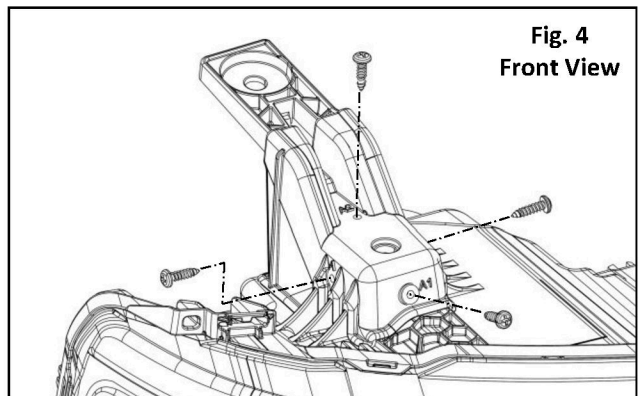
4. Install: Install the prepared tab(s) ensuring a flush fit to the housing **Fig. 4**. Drive the 5/8" screws at the locations marked **(A1)**, followed by **(A2)** then location **(A)**. Do not overtighten the screws. Allow the glue to cure for approximately 30 minutes before installing the repaired headlight on the vehicle.

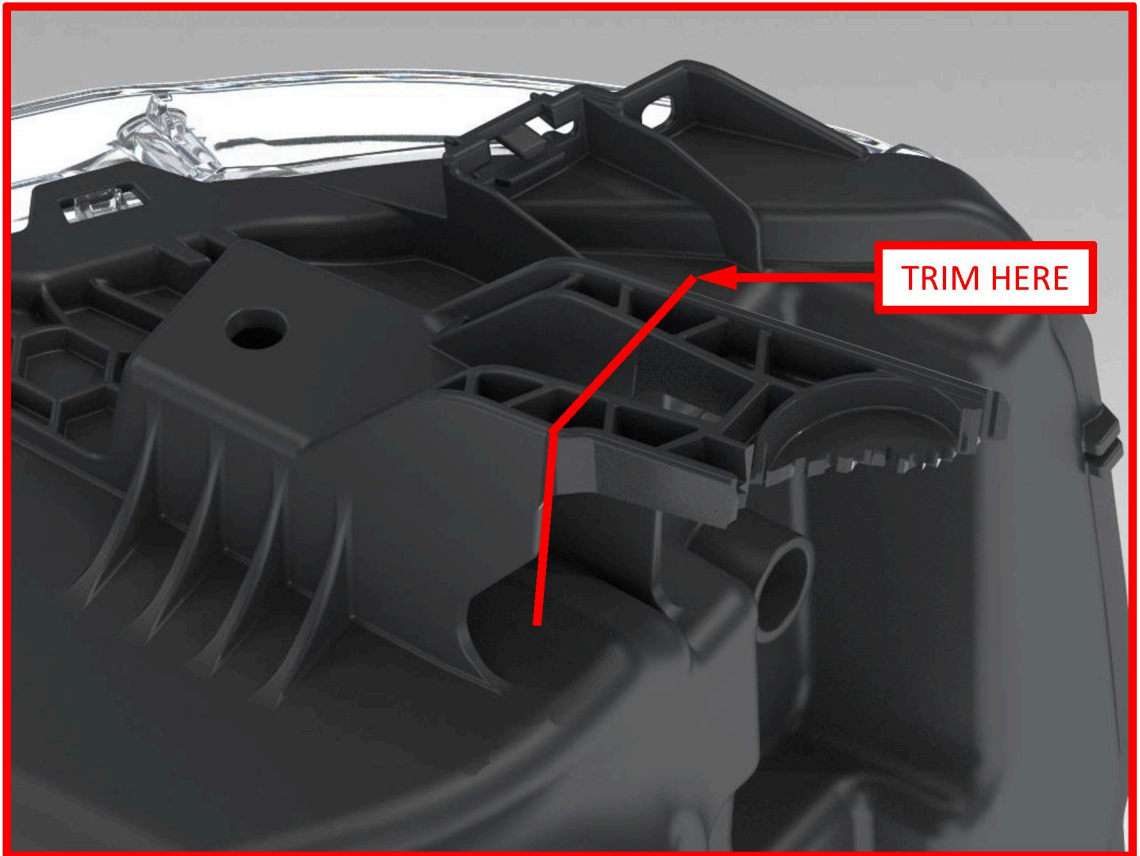
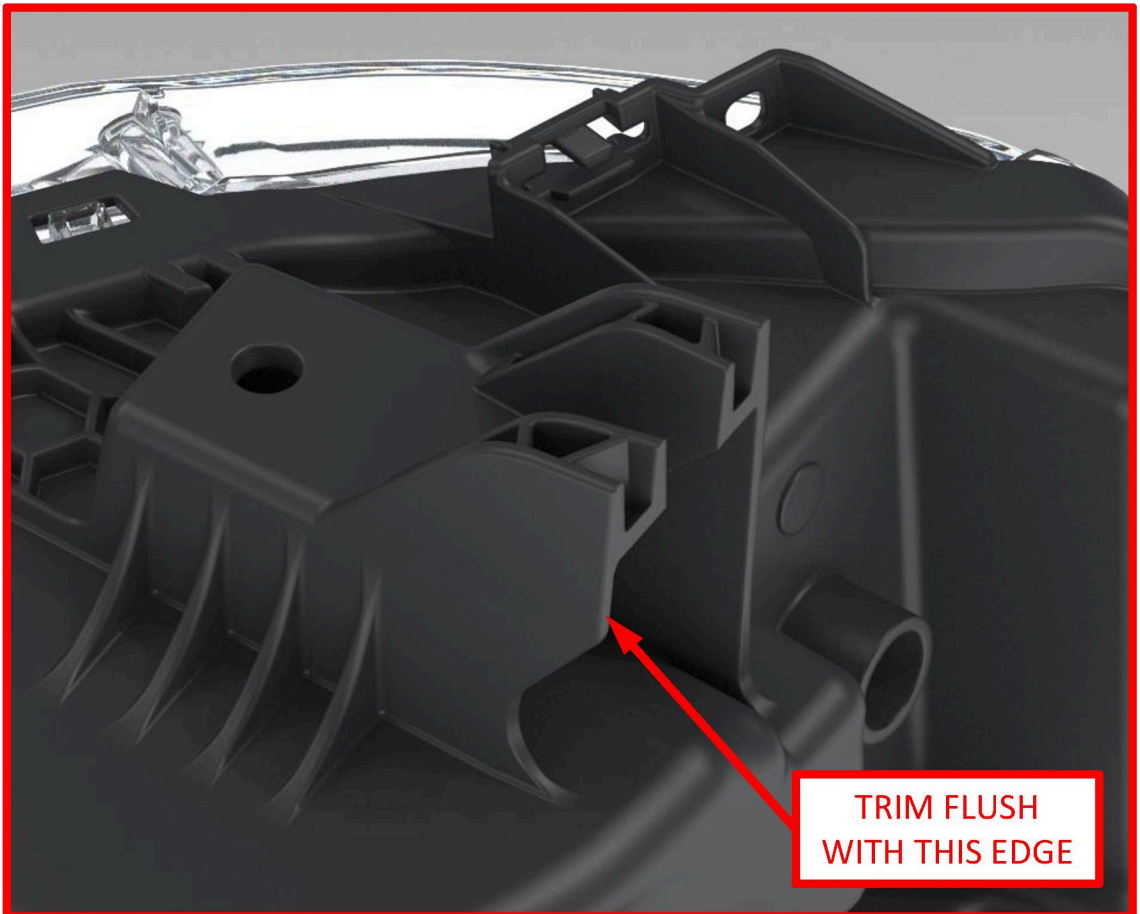
SEE REVERSE SIDE for views of properly trimmed headlamp tab.
