## 2016-18 CHEVY SILVERADO 1500 HID LED RH LWR OUTBOARD HEADLIGHT TAB KIT P/N 25-10039

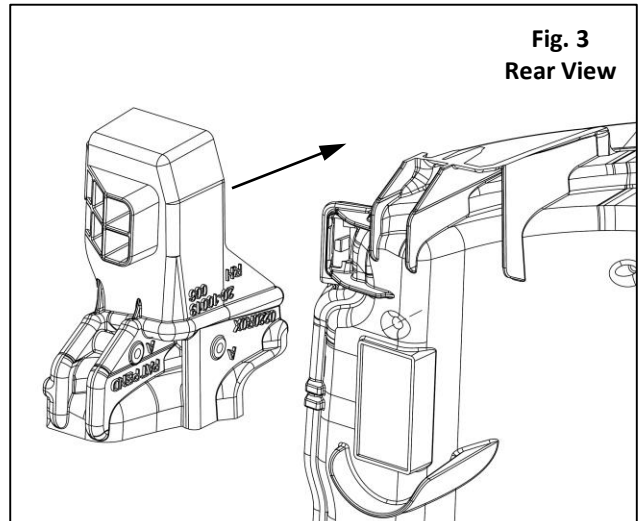
**2. Dry-Fit:** Dry-fit the repair tab(s) **Fig. 3**. If the tab fits without resistance and makes a flush fit to the housing, trimming is complete. If the tab resists installation re-trim the damaged tab, removing only small amounts of material. Repeat the Dry-Fit steps until the proper fit is achieved.

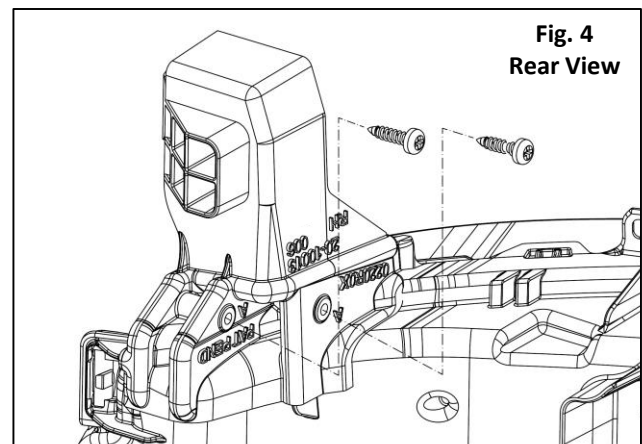
**4. Install:** Install the prepared tab(s) ensuring a flush fit to the housing **Fig. 4**. Next, drive the 5/8" screws at the locations marked **(A)**. Do not over-tighten the screws. Allow the glue to cure for approximately 30 minutes before installing the repaired headlight on the vehicle.

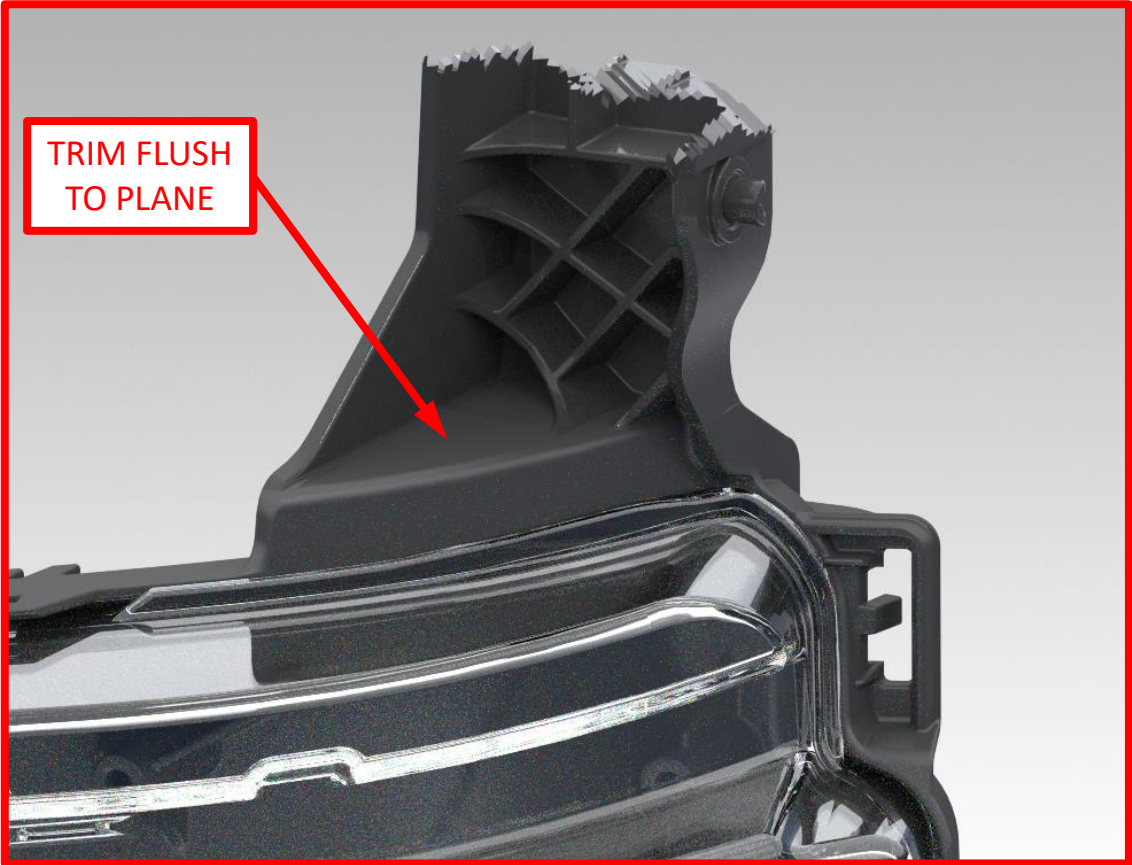
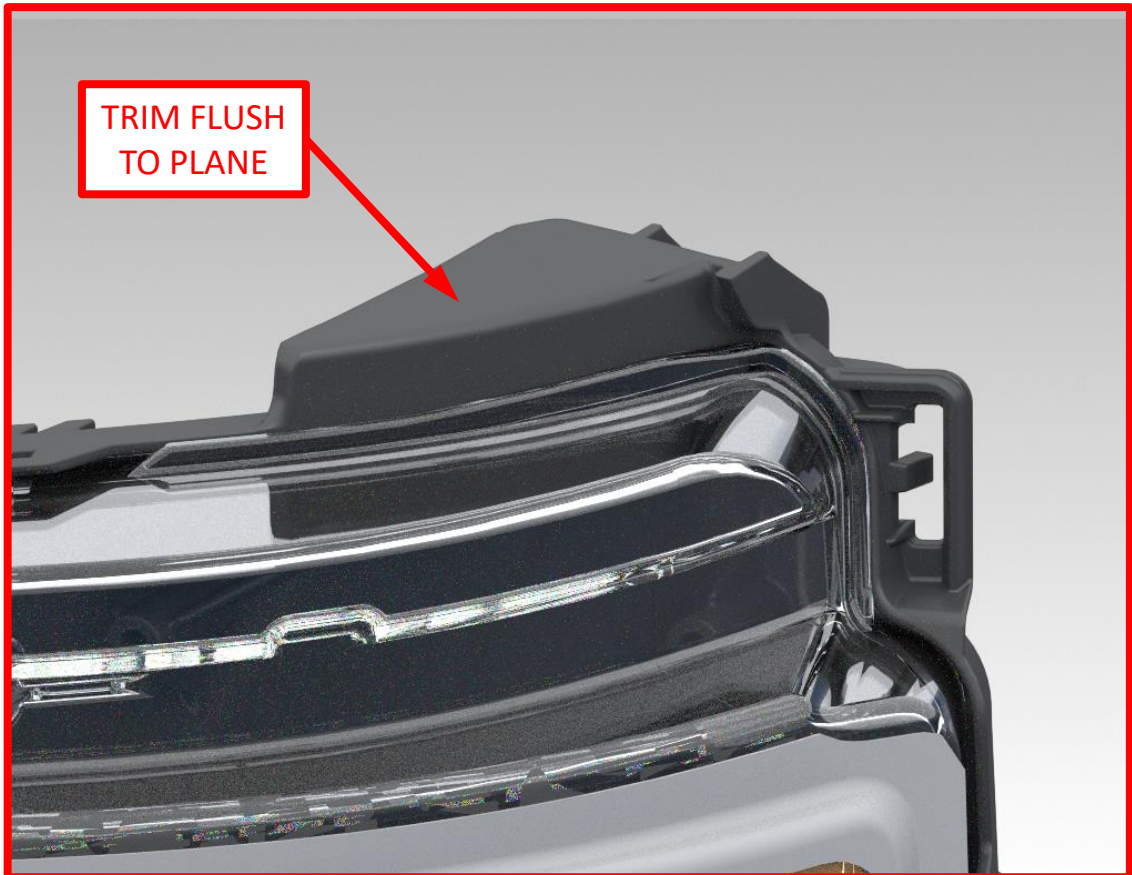
SEE REVERSE SIDE for views of properly trimmed headlamp tab.
