## 2016-18 CHEVY SILVERADO 1500 HID LED LH UPR INBOARD HEADLIGHT TAB KIT P/N 25-10041

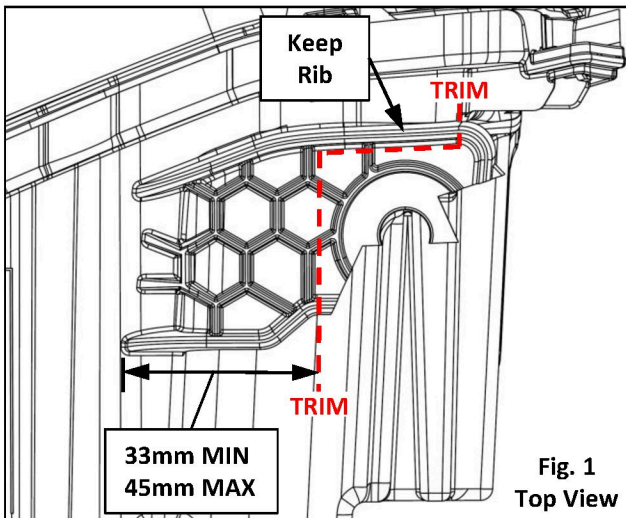
**1. Trim:** Using a cut-off wheel, trim the damaged tab to the **MAX** dimension whenever possible, **Fig. 1**. Make note of the trimming plane to which the **MAX** dimension refers, **Fig. 2**. The **MIN** indicates the least amount of material allowed for proper screw engagement. Next, Sand rough edges to remove excess material from trimming and to ensure a proper fit.

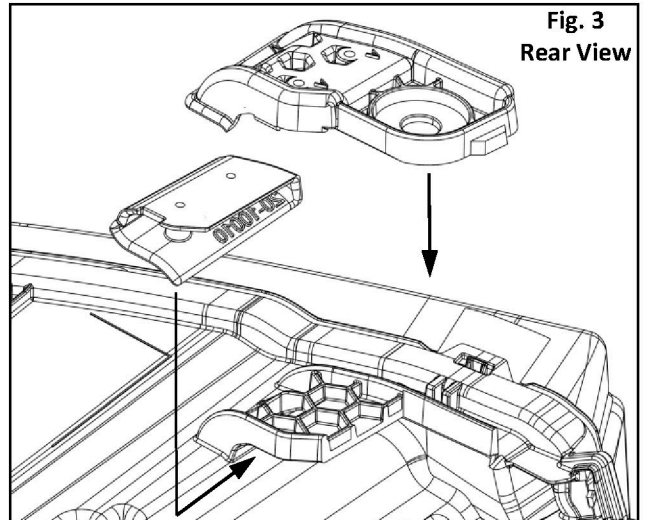
**2. Dry-Fit:** Dry-fit the repair tab(s) **Fig. 3**. If the tab fits without resistance and makes a flush fit to the housing, trimming is complete. If the tab resists installation re-trim the damaged tab, removing only small amounts of material. Repeat the Dry-Fit steps until the proper fit is achieved.

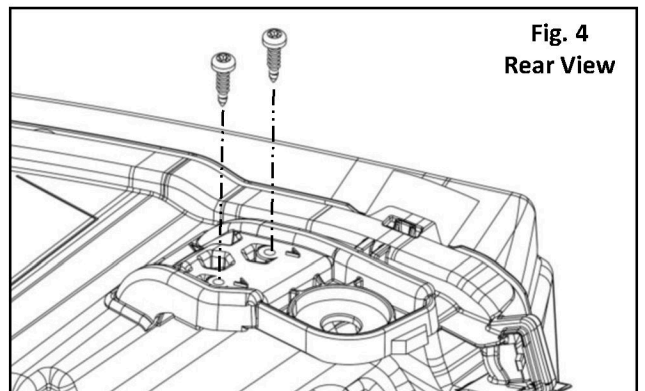
**4. Install:** Install the prepared tab(s) ensuring a flush fit to the housing **Fig. 4**. Next, drive the two 5/8" screws at the locations marked (A). Do not overtighten the screws. Allow the glue to cure for approximately 30 minutes before installing the repaired headlight on the vehicle.

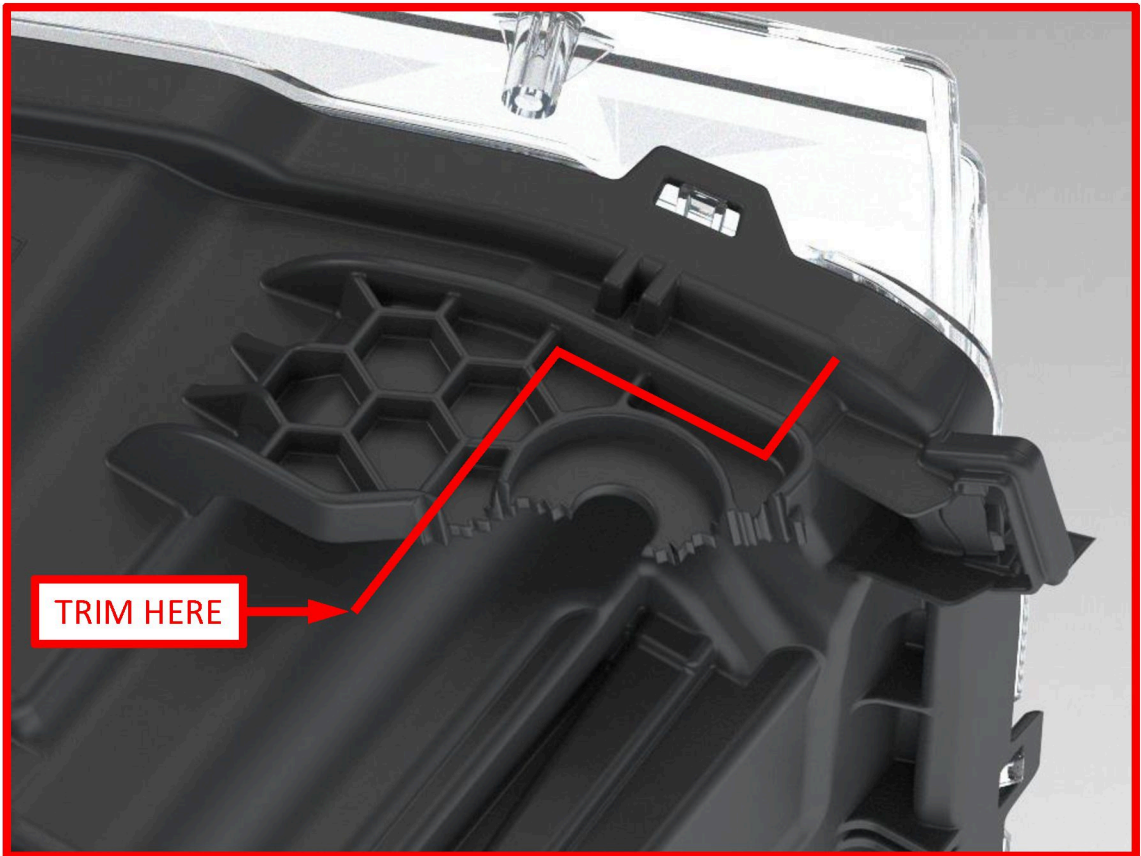
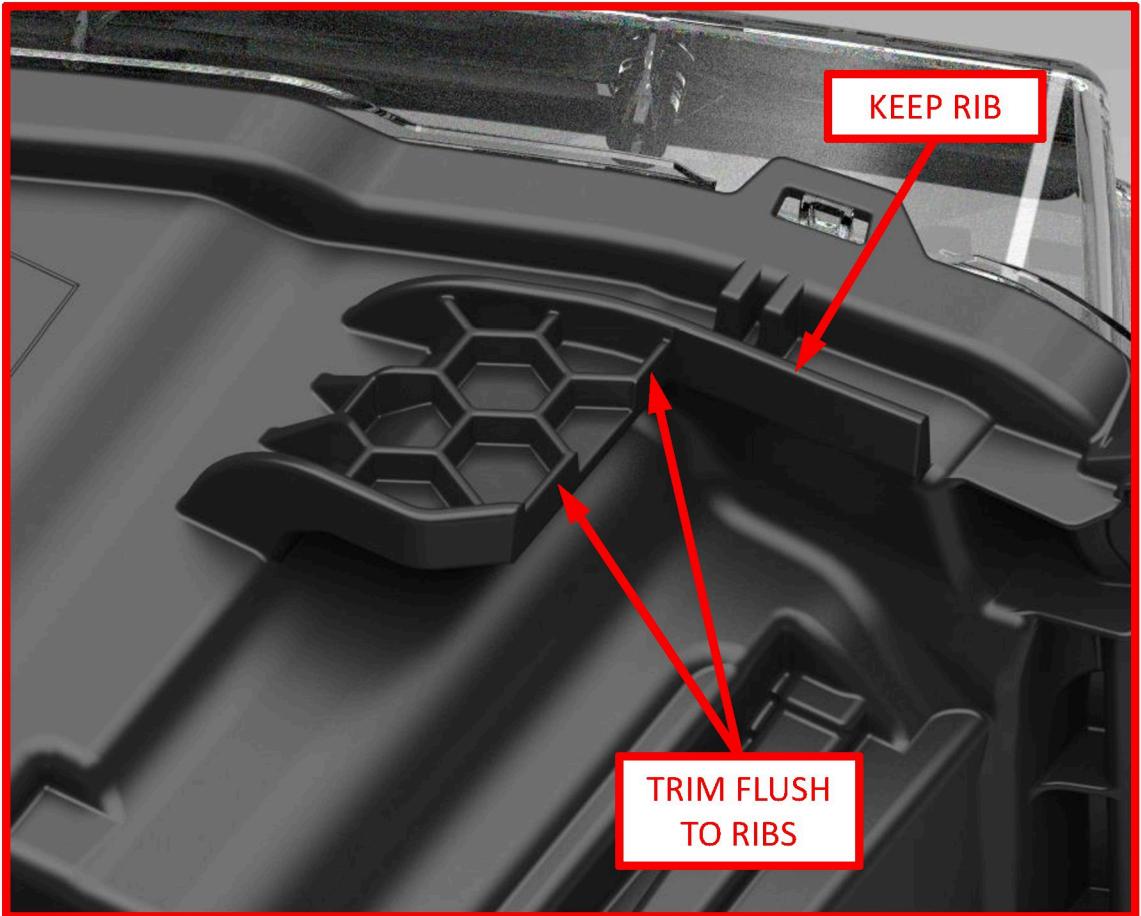
SEE REVERSE SIDE for views of properly trimmed headlamp tab.
