2016-18 CHEVY SILVERADO 1500 HID LED LH UPR OUTBOARD HEADLIGHT TAB KIT P/N 25-10042

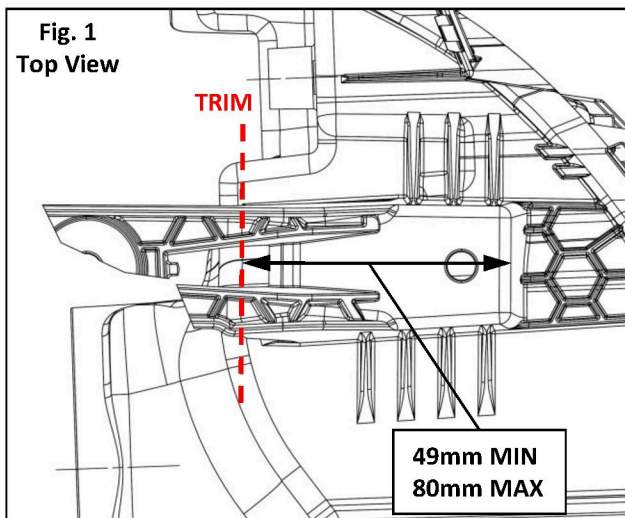
1. Trim: Using a cut-off wheel, trim the damaged tab to the **MAX** dimension whenever possible, **Fig. 1**. Make note of the trimming plane to which the **MAX** dimension refers, **Fig. 2**. The **MIN** indicates the least amount of material allowed for proper screw engagement. Next, Sand rough edges to remove excess material from trimming and to ensure a proper fit.

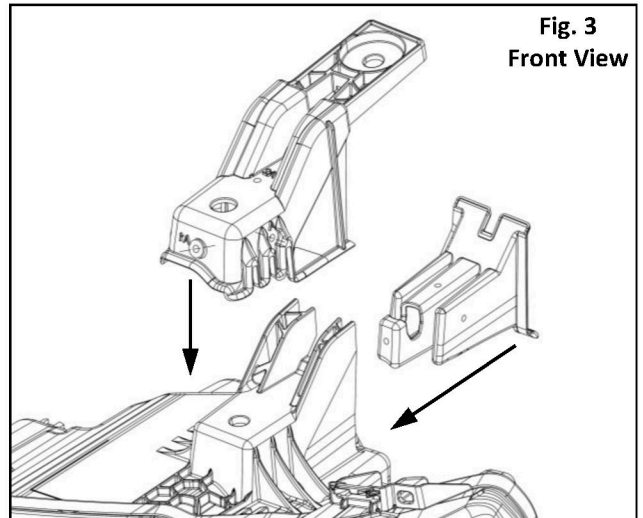
2. Dry-Fit: Dry-fit the repair tab(s) **Fig. 3**. If the tab fits without resistance and makes a flush fit to the housing, trimming is complete. If the tab resists installation re-trim the damaged tab, removing only small amounts of material. Repeat the Dry-Fit steps until the proper fit is achieved.

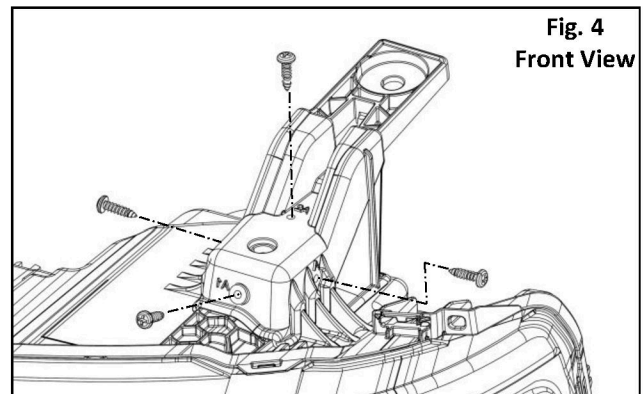
4. Install: Install the prepared tab(s) ensuring a flush fit to the housing **Fig. 4**. Drive the 5/8" screws at the locations marked **(A1)**, followed by **(A2)** then location **(A)**. Do not overtighten the screws. Allow the glue to cure for approximately 30 minutes before installing the repaired headlight on the vehicle.

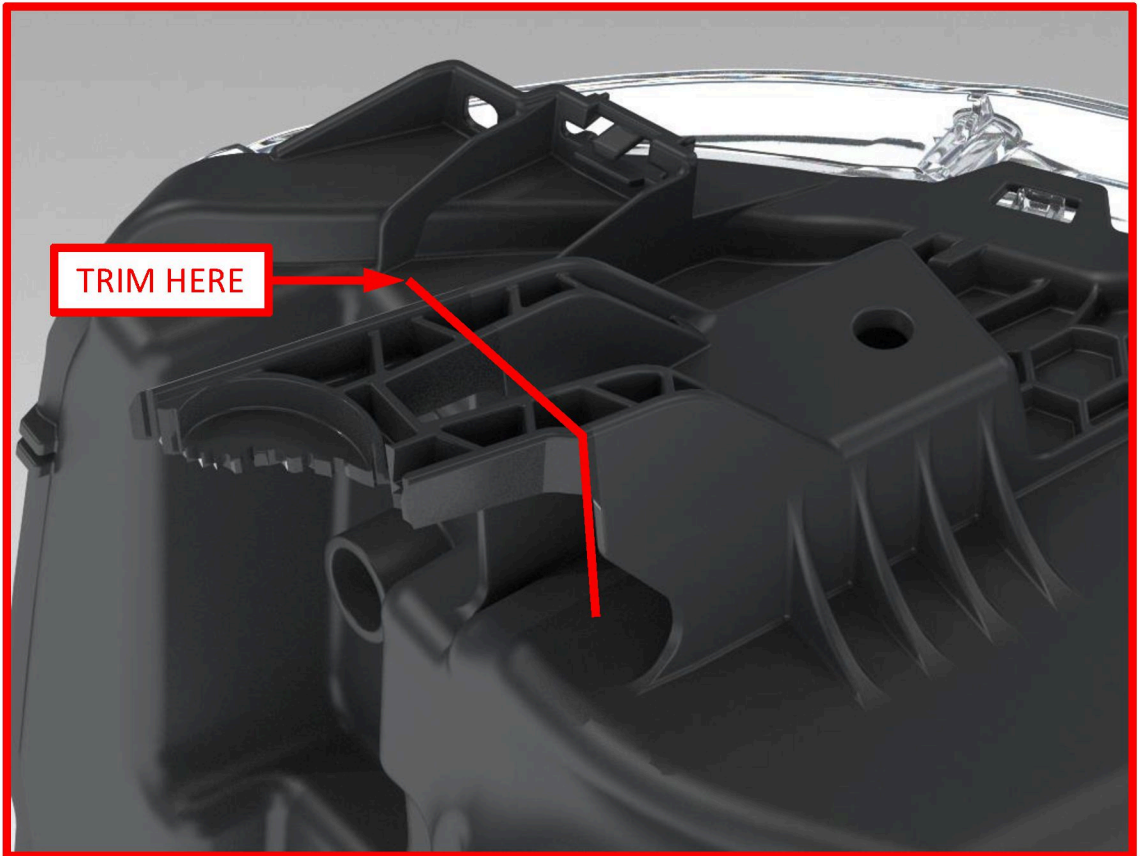
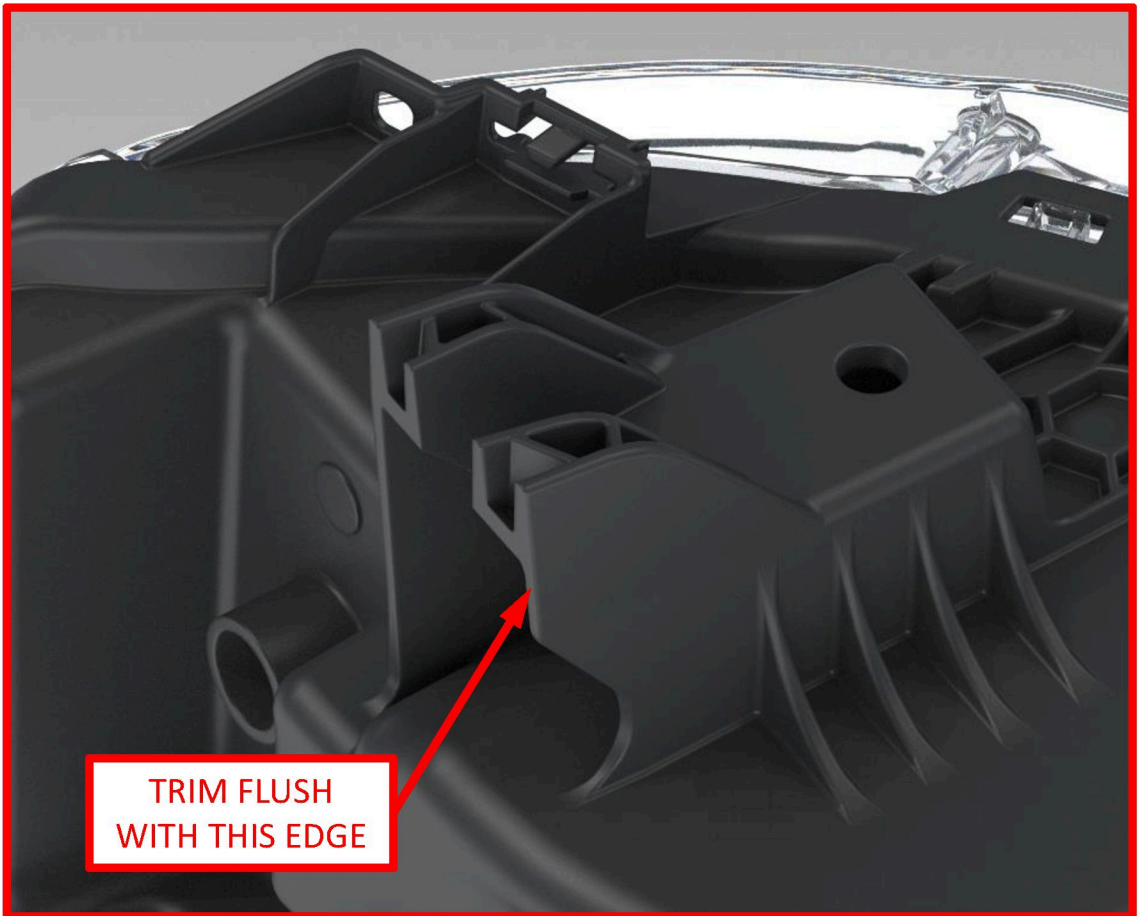
SEE REVERSE SIDE for views of properly trimmed headlamp tab.
