2016-18 CHEVY SILVERADO 1500 HID LED LH LWR OUTBOARD HEADLIGHT TAB KIT P/N 25-10043

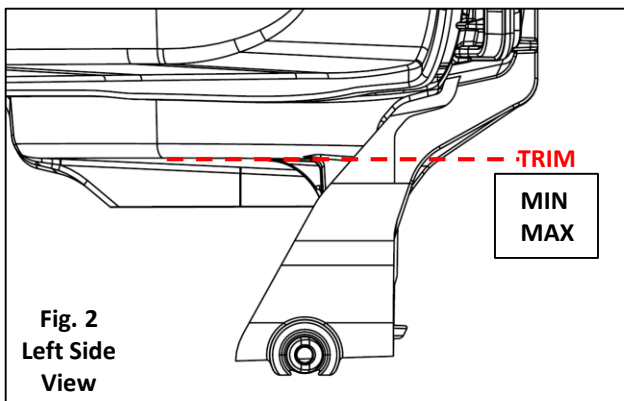
1. Trim: Using a cut-off wheel, trim the damaged tab to the **MAX** dimension whenever possible. Make note that in this case the trimming line is both the **MIN** and **MAX** dimension, **Fig. 1**. Trim flush to the plane marked **MIN MAX**, **Fig. 2**. Next, Sand rough edges to remove excess material from trimming and to ensure a proper fit.

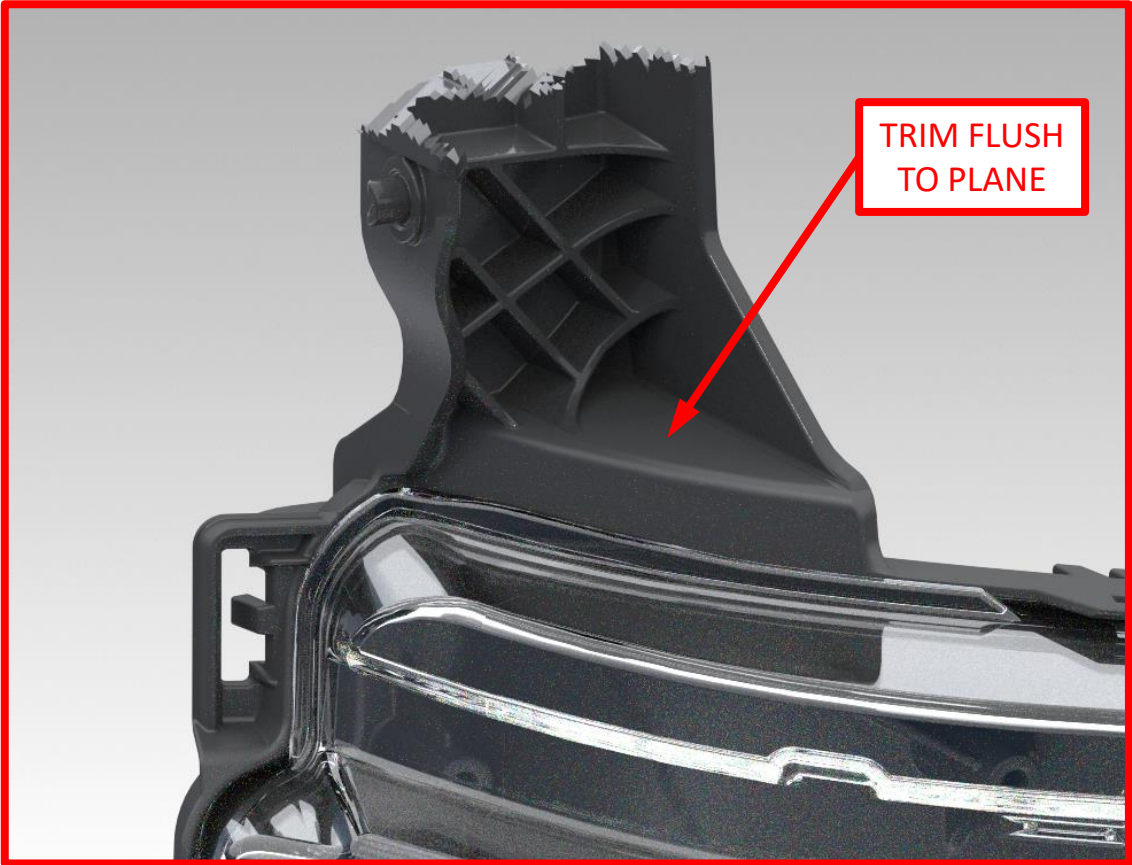
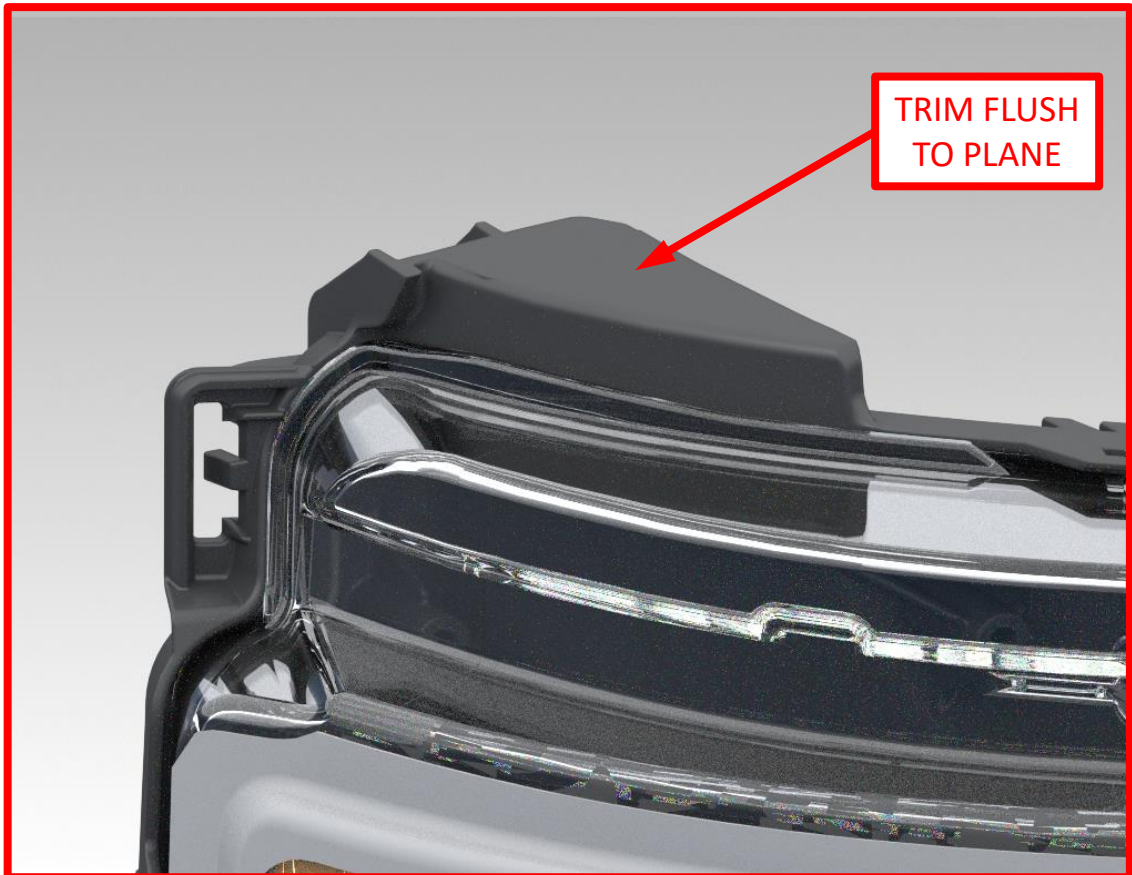
SEE REVERSE SIDE for views of properly trimmed headlamp tab.
