2014-18 GMC SIERRA RH LWR INBOARD HEADLIGHT TAB KIT ALL P/N 25-10004

(Please visit CreativeRepairSolutions.com for detailed instruction videos.)

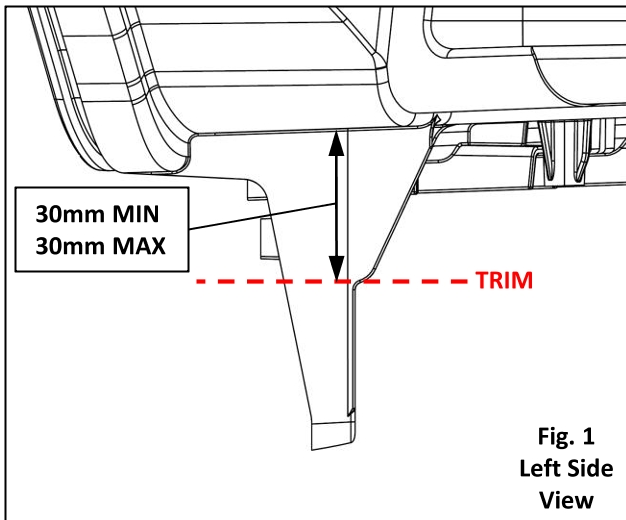
1. Trim: Using a cut-off wheel, trim the damaged tab to the **MAX** dimension whenever possible, **Fig. 1**. Make note of the trimming plane to which the **MAX** dimension refers, **Fig. 2**. The **MIN** indicates the least amount of material allowed for proper screw engagement. Next, Sand rough edges to remove excess material from trimming and to ensure a proper fit.

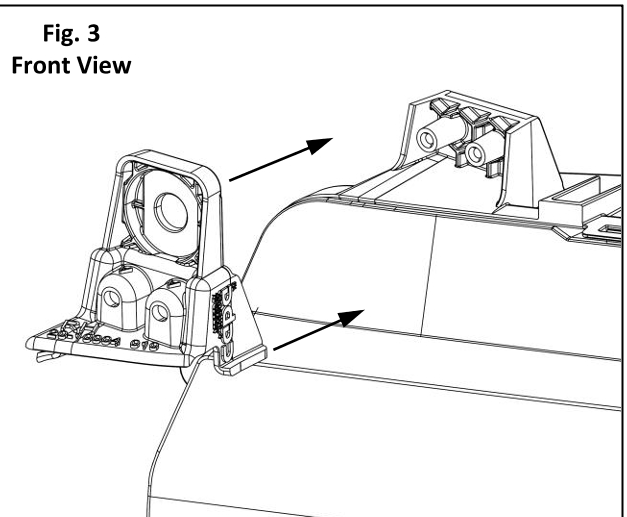
2. Dry-Fit: Dry-fit the repair tab(s) **Fig. 3**. If the tab fits without resistance and makes a flush fit to the housing, trimming is complete. If the tab resists installation re-trim the damaged tab, removing only small amounts of material. Repeat the Dry-Fit steps until the proper fit is achieved.

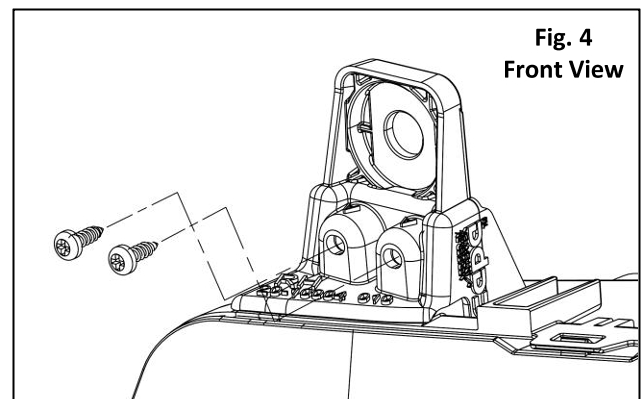
4. Install: Install the prepared tab(s) ensuring a flush fit to the housing **Fig. 4**. Next, drive the two 5/8" screws at the locations marked (A). Do not over-tighten the screws. Allow the glue to cure for approximately 30 minutes before installing the repaired headlight on the vehicle.

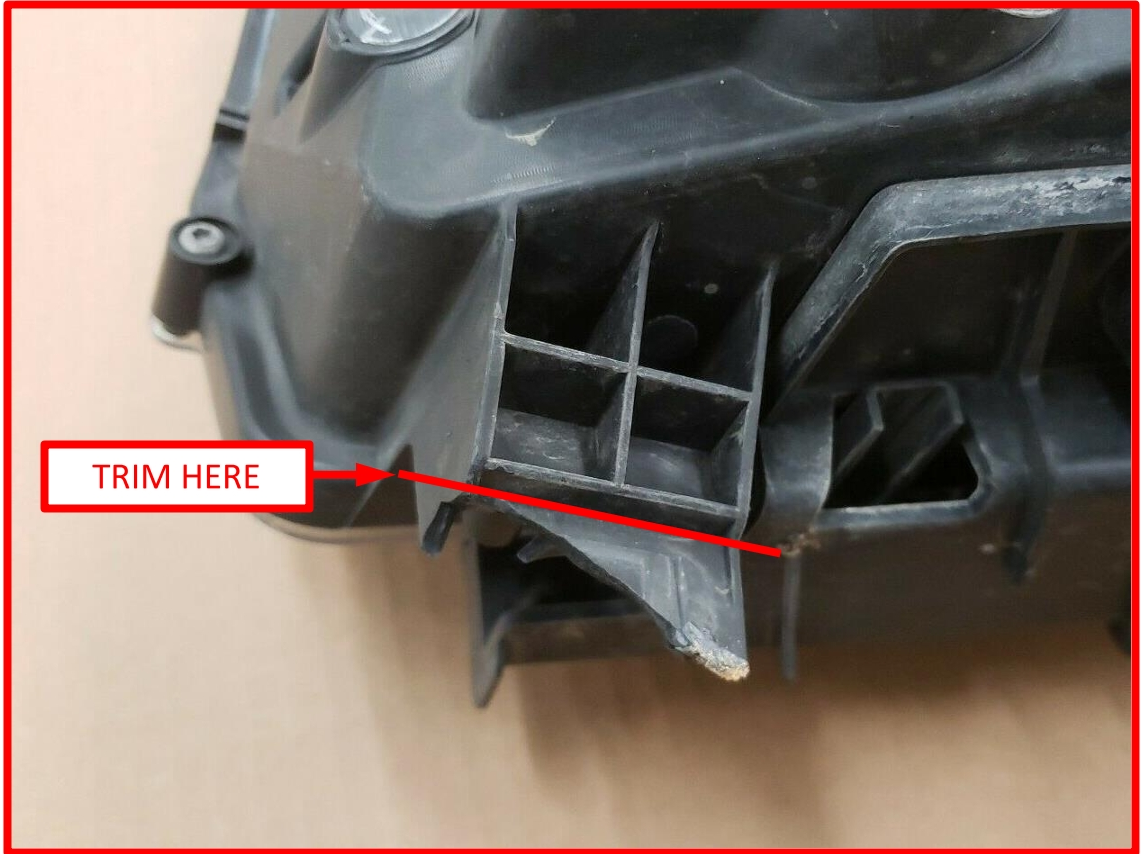
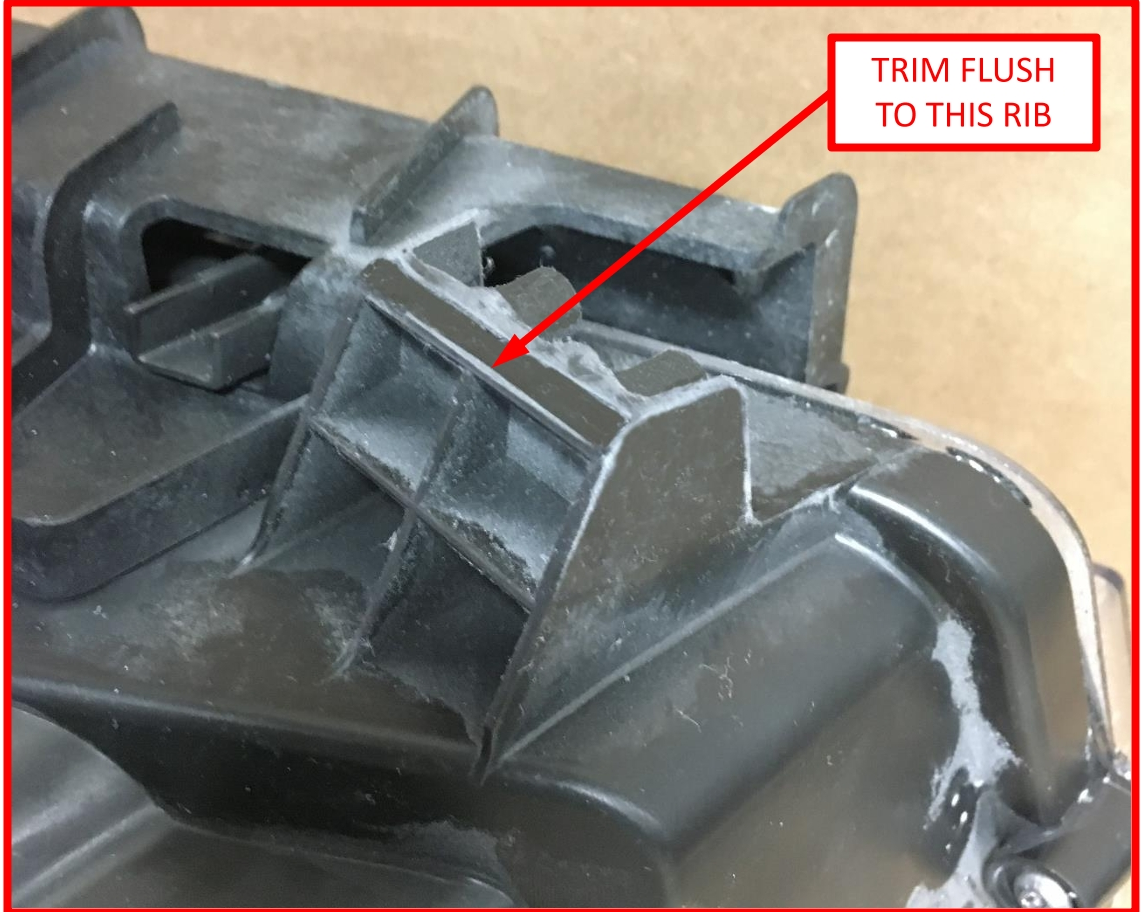
SEE REVERSE SIDE for views of properly trimmed headlamp tab.
