2016-18 CHEVY SILVERADO 1500 HID LED RH LWR INBOARD HEADLIGHT TAB KIT P/N 25-10040

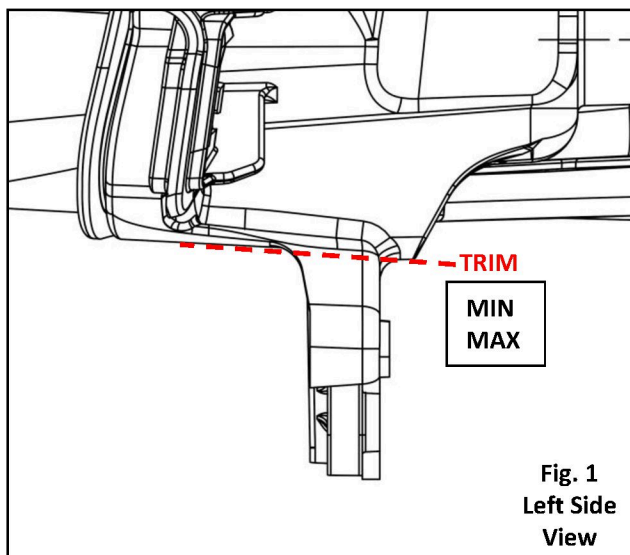
1. Trim: Using a cut-off wheel, trim the damaged tab to the **MAX** dimension whenever possible, **Fig. 1**. Make note that in this case the trimming line is both the **MIN** and **MAX** dimension, **Fig. 1**. Trim flush to the plane marked **MIN MAX**, **Fig. 2** Next, Sand rough edges to remove excess material from trimming and to ensure a proper fit.

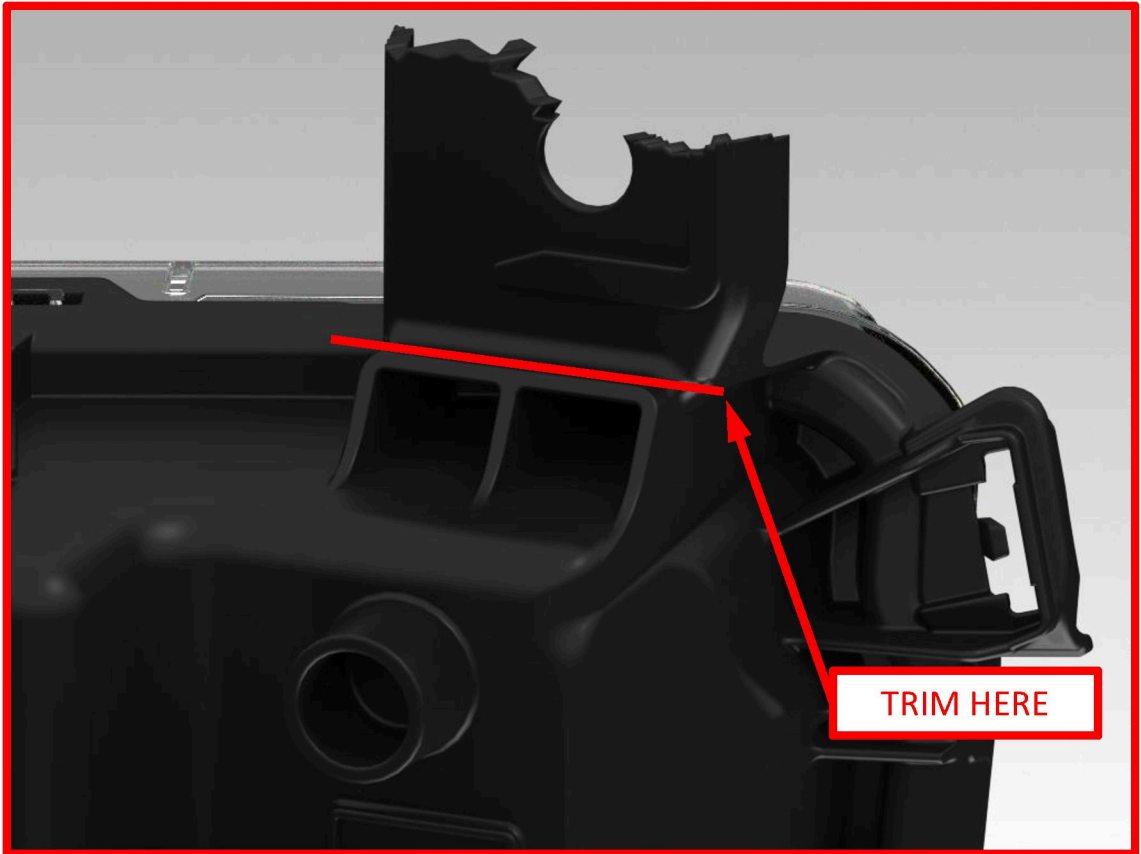
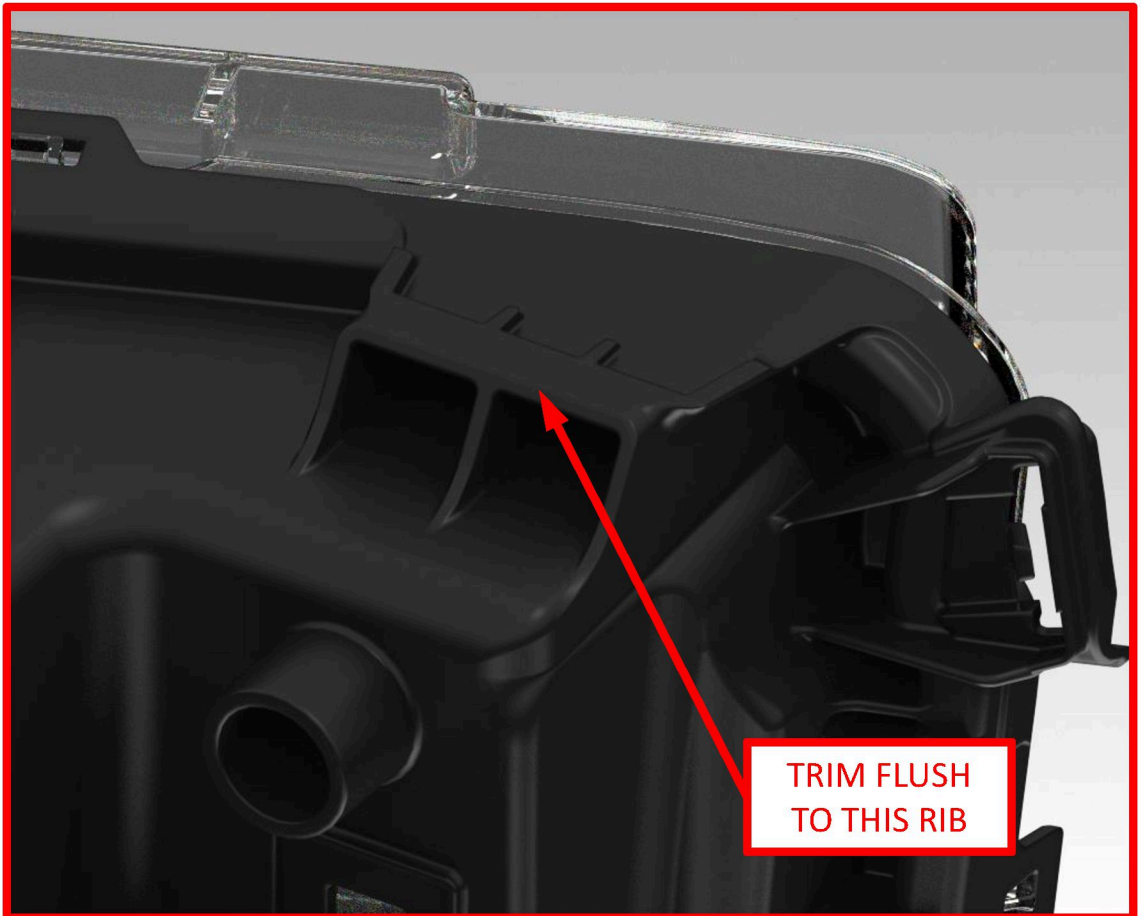
SEE REVERSE SIDE for views of properly trimmed headlamp tab.
