2016-18 CHEVY SILVERADO 1500 HID LED LH LWR INBOARD HEADLIGHT TAB KIT P/N 25-10044

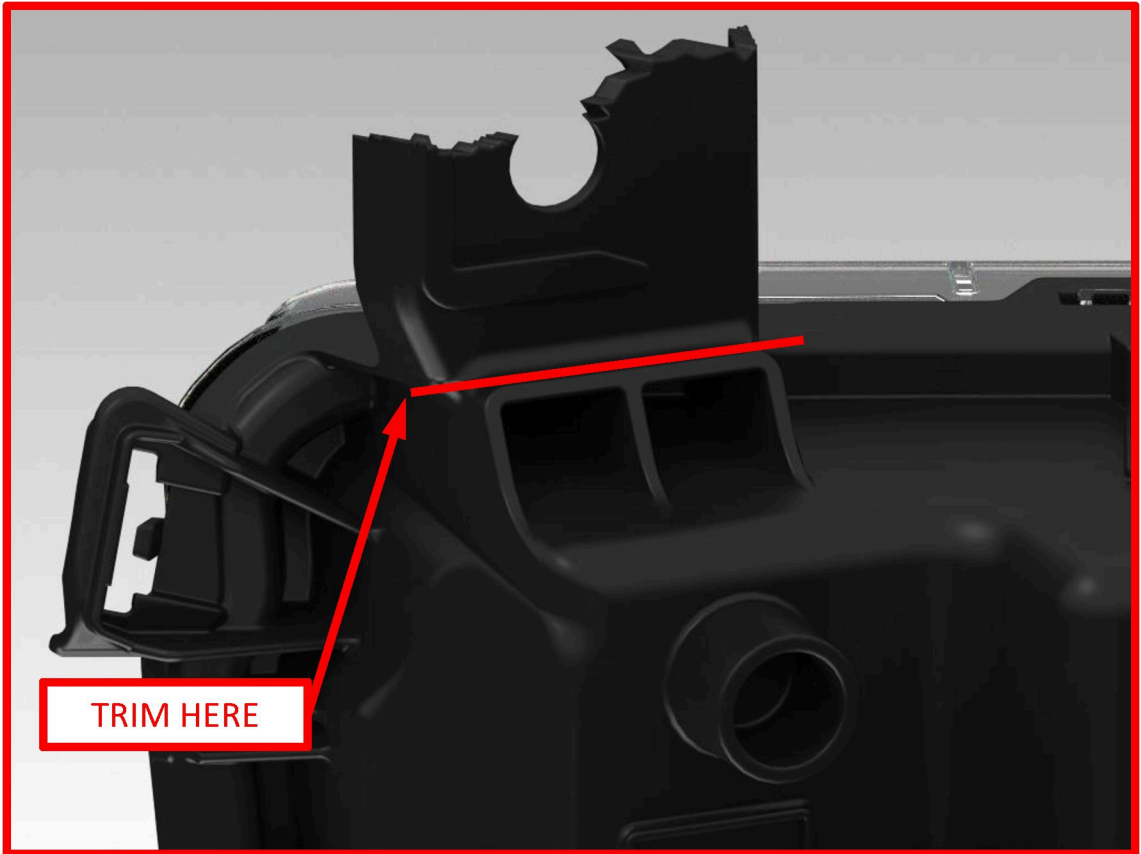
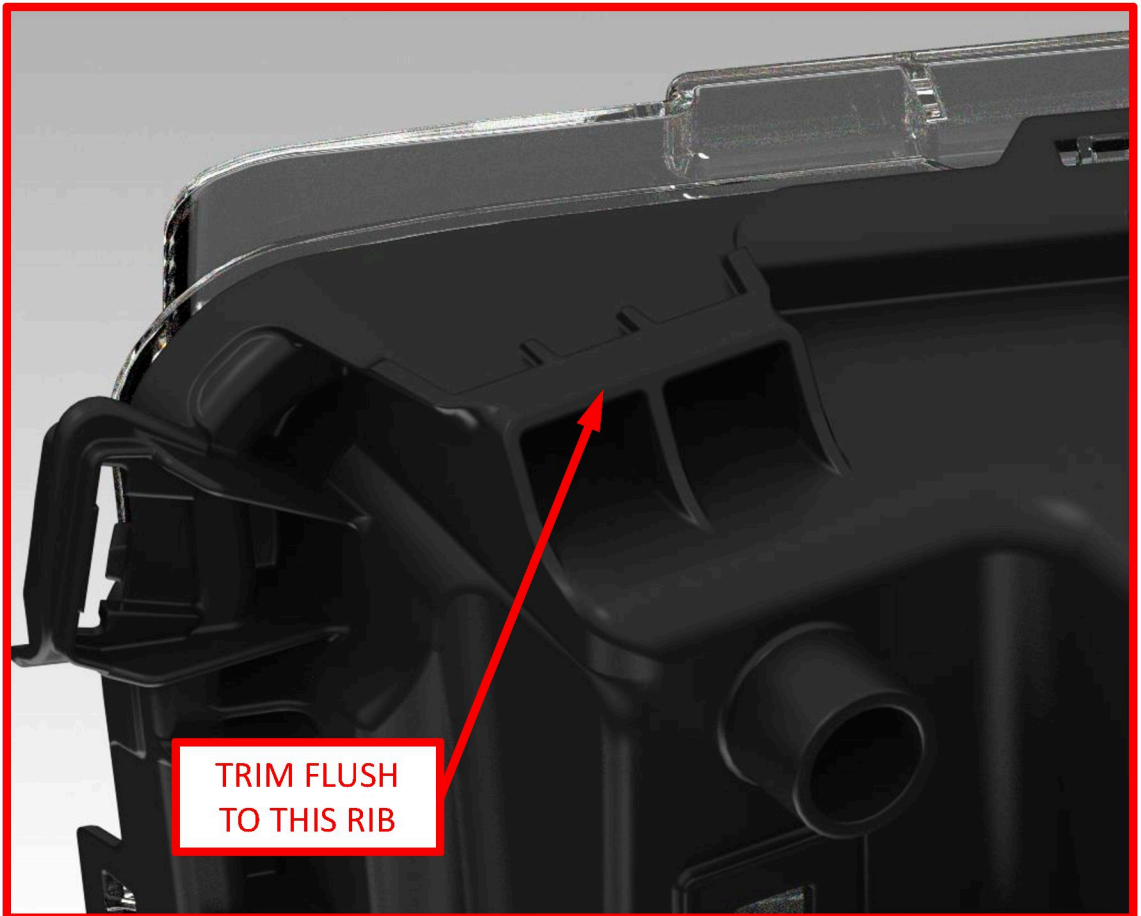
SEE REVERSE SIDE for views of properly trimmed headlamp tab.
