## F150 RH UPR OB HEADLIGHT TAB HAL P/N 25-10125

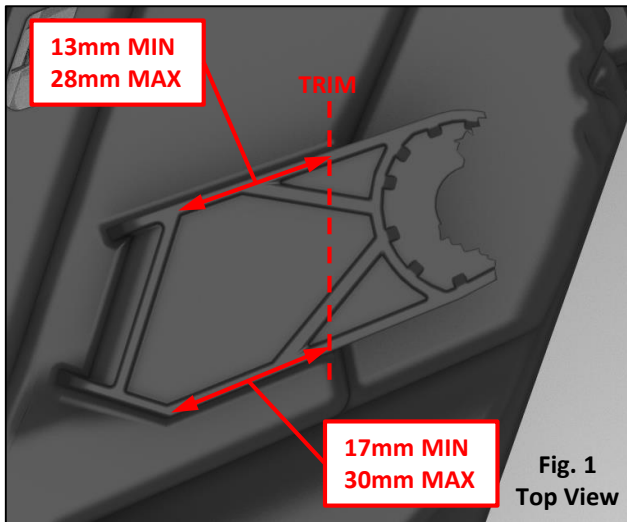
Fig. 1  
Top View

**1. Trim:** Using a cut-off wheel, trim the damaged tab to the **MAX** dimension whenever possible, **Fig. 1**. Make note of the trimming plane to which the **MAX** dimension refers, **Fig. 2**. The **MIN** indicates the least amount of material allowed for proper screw engagement. Next, Sand rough edges to remove excess material from trimming and to ensure a proper fit.

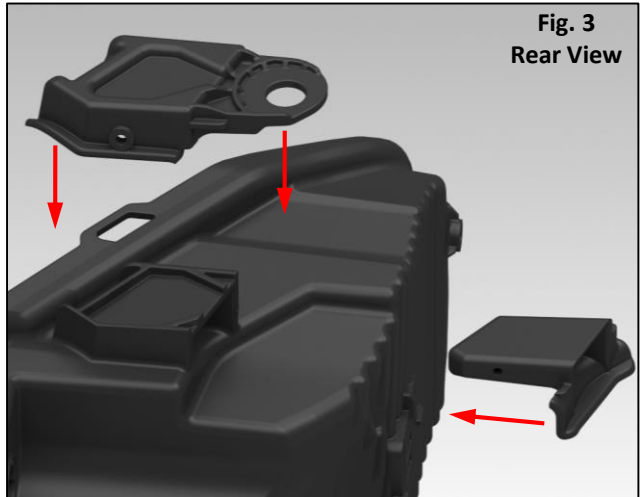
Fig. 3  
Rear View

**2. Dry-Fit:** Dry-fit the repair tab(s) **Fig. 3**. If the tab fits without resistance and makes a flush fit to the housing, trimming is complete. If the tab resists installation re-trim the damaged tab, removing only small amounts of material. Repeat the Dry-Fit steps until the proper fit is achieved.

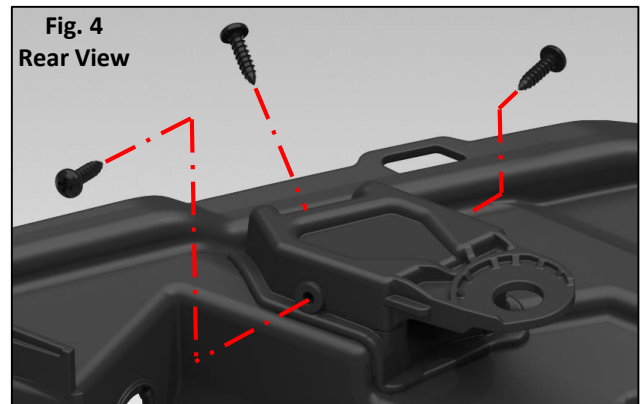
Fig. 4  
Rear View

**4. Install:** Install the prepared tab(s) ensuring a flush fit to the housing **Fig. 4**. Next, drive the 5/8" screw at the location marked **(A1)**, followed by locations marked **(A)**, while holding parts firmly together. **APPLY GLUE TO SCREW THREADS BEFORE DRIVING.** Do not overtighten screws. Allow the glue to cure for approximately 30 minutes before installing the repaired headlight on the vehicle.

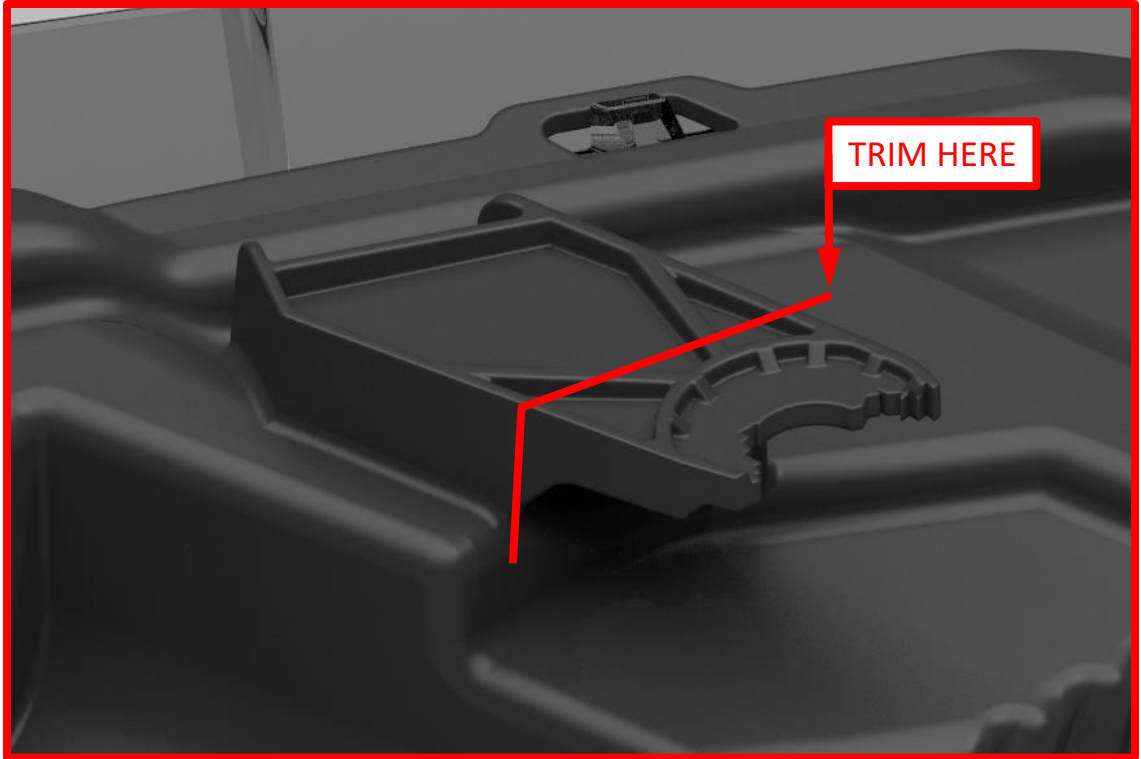
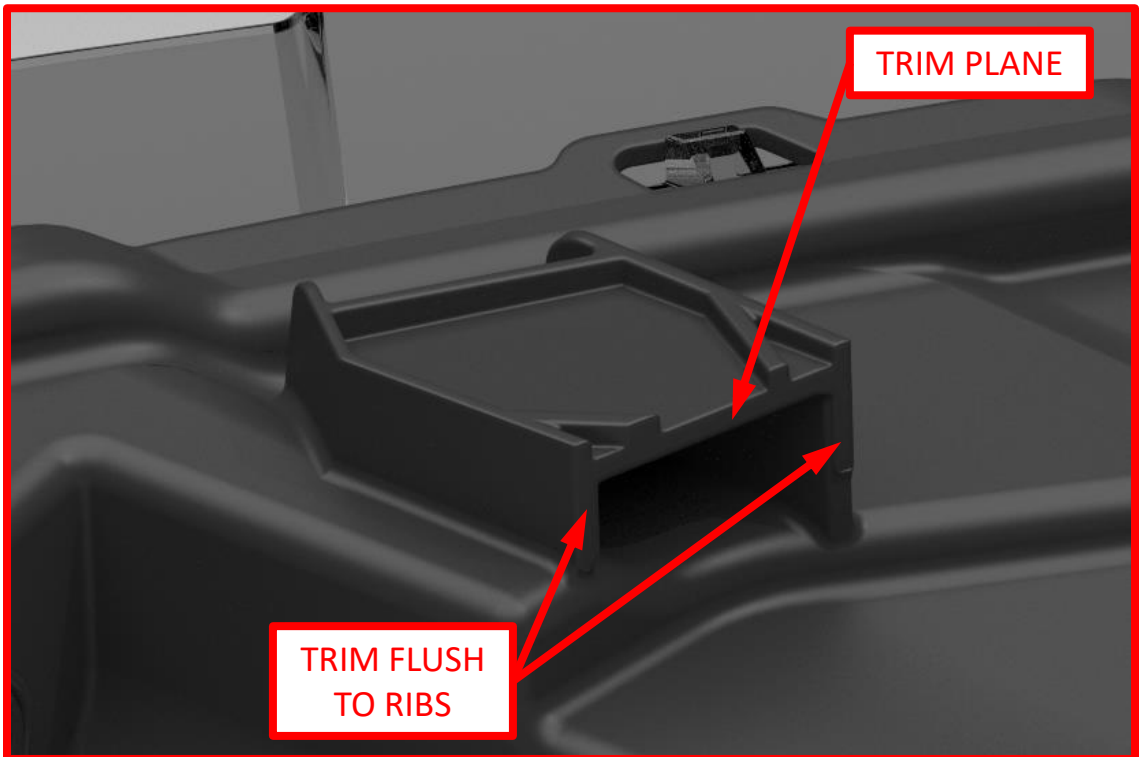
SEE REVERSE SIDE for views of properly trimmed headlamp tab.
